RESTORING HISTORICAL IRONWORK

A Case Study

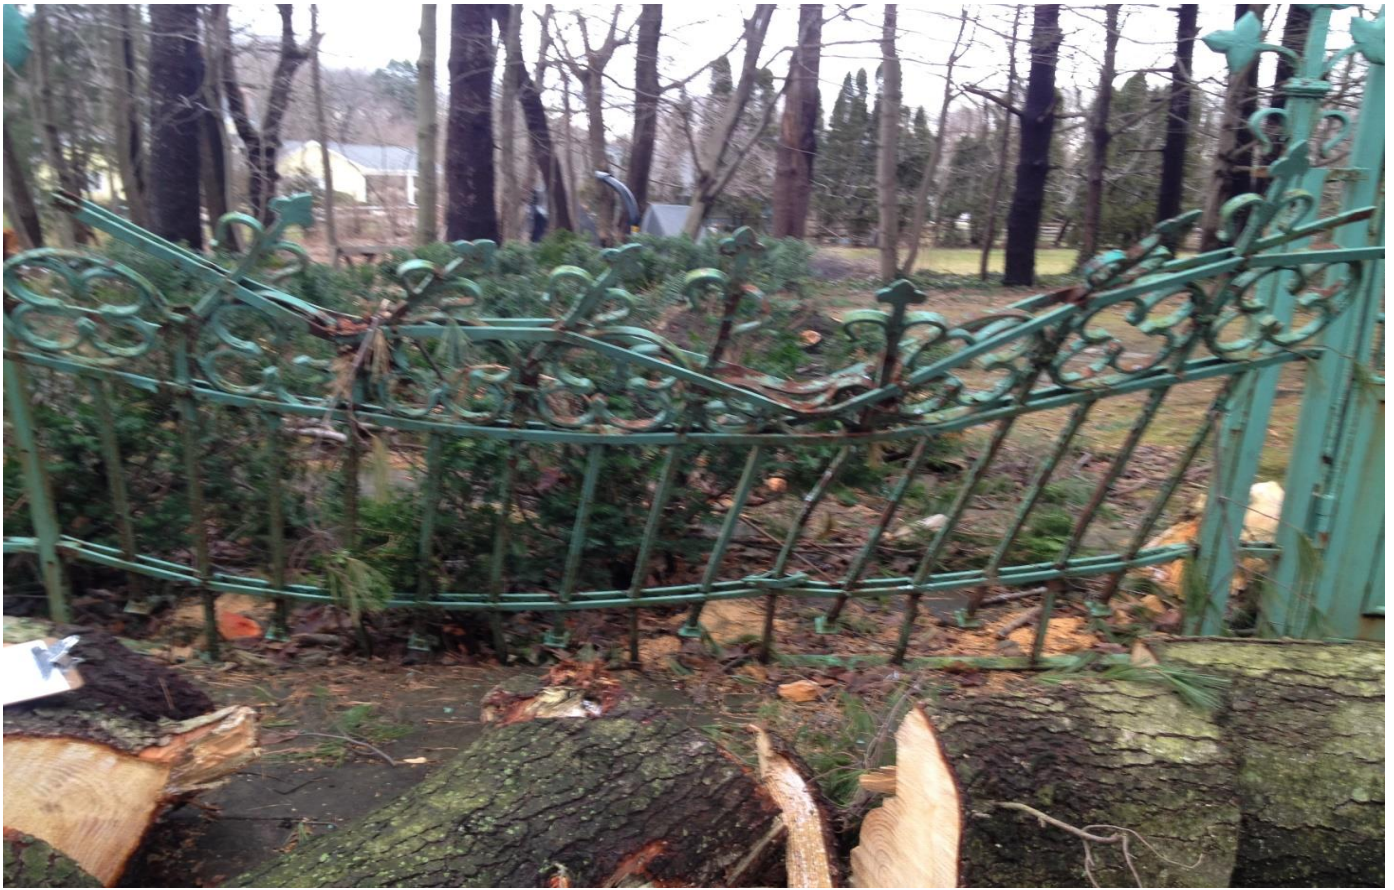
Spirit Ironworks was approached by a local client who wanted to have her antique fencing possibly from the late 1800's restored. The ironwork, located in Historic Old Field on the North Shore of Long Island, was badly damaged when a large tree and other debris fell on it during hurricane Sandy in 2012.

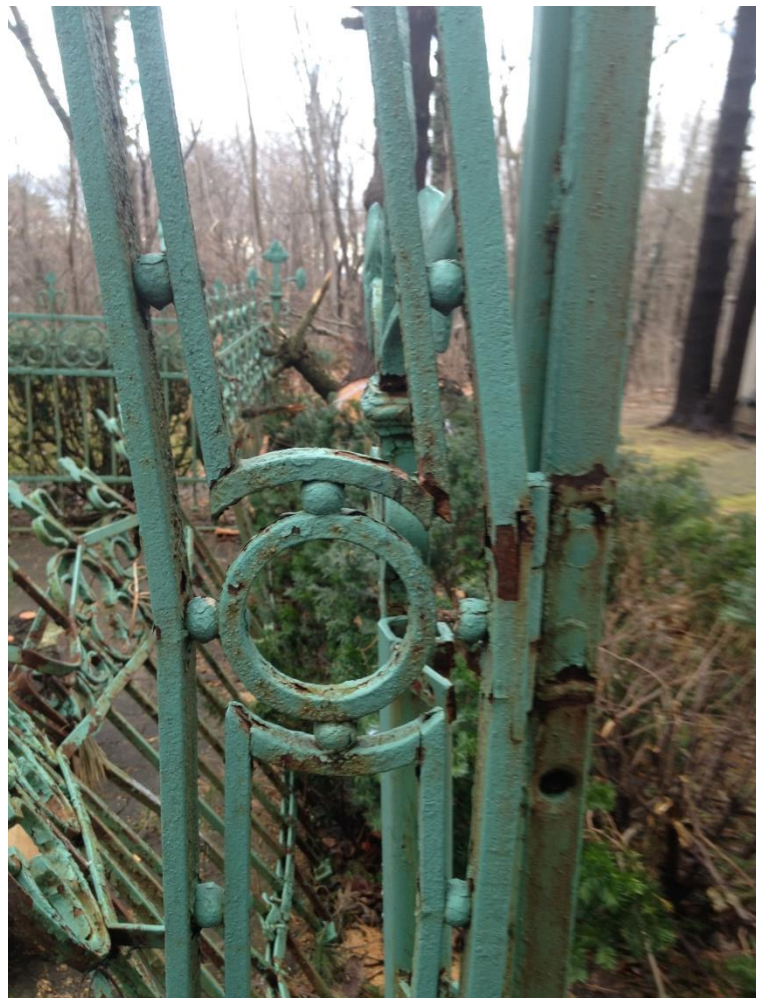
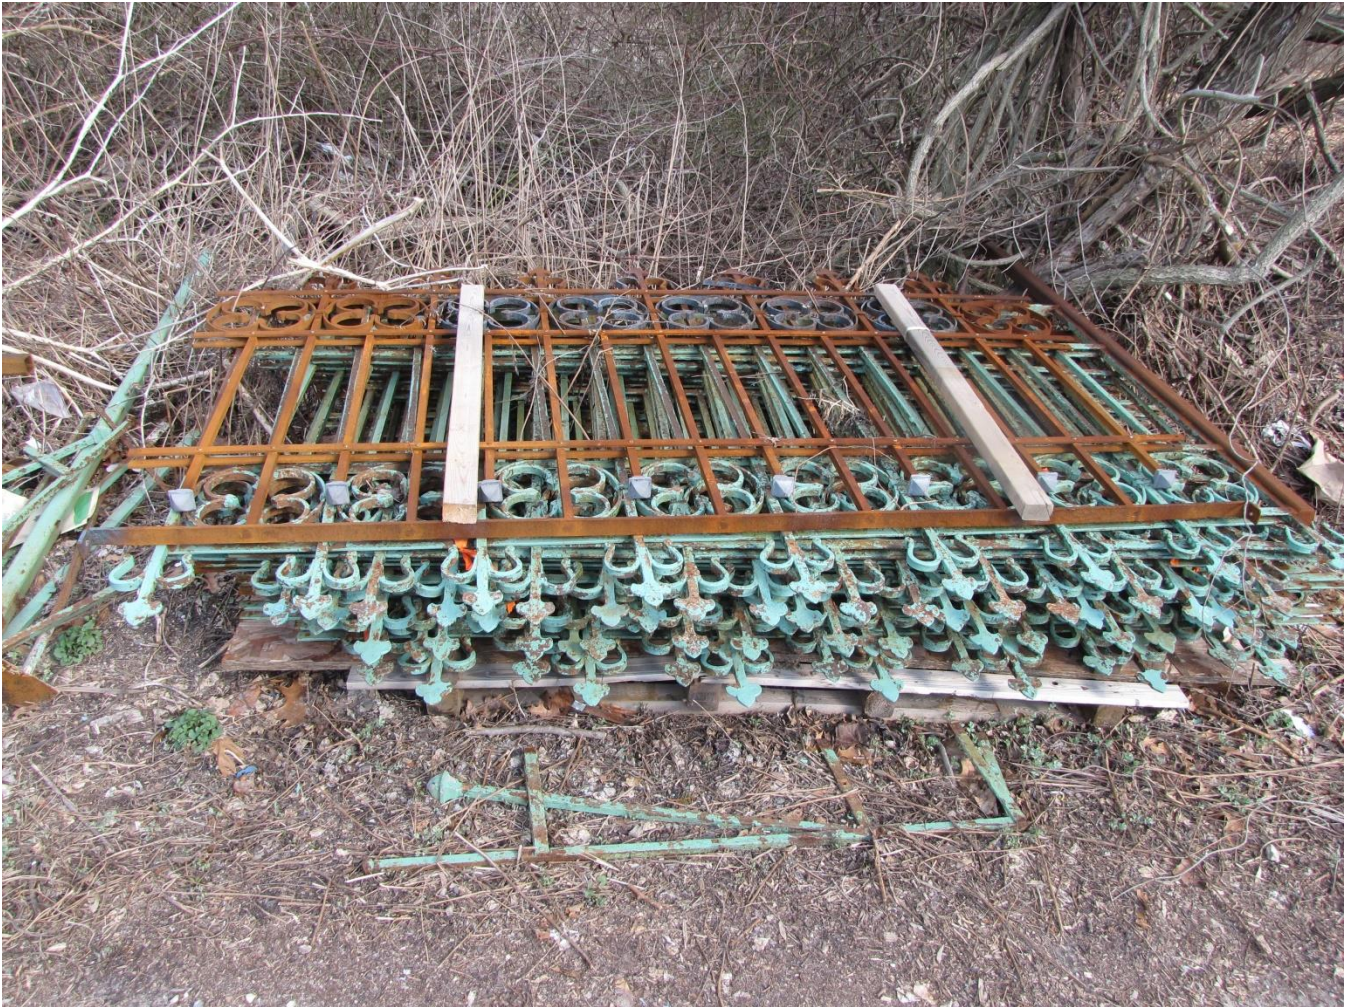
A number of metalworkers viewed the damaged fencing but turned down the project due to their lack of experience in historical restoration and repair. The fencing itself was constructed entirely without the use of electric welding. Instead, the original ornamental blacksmith who built the ironwork used methods such as forge welding, hot bending, forging and riveting. In addition, there were cast white metal ornaments, hot fit collars, slot and tab joints and others methods rarely seen today. This type of construction is generally not used in a modern metal work. Working this way is considerably more difficult and time consuming, though the results are often more pleasing to the eye. Furthermore, it is very difficult to find competent workers capable of executing this kind of work. As you can see, the damage was extensive.

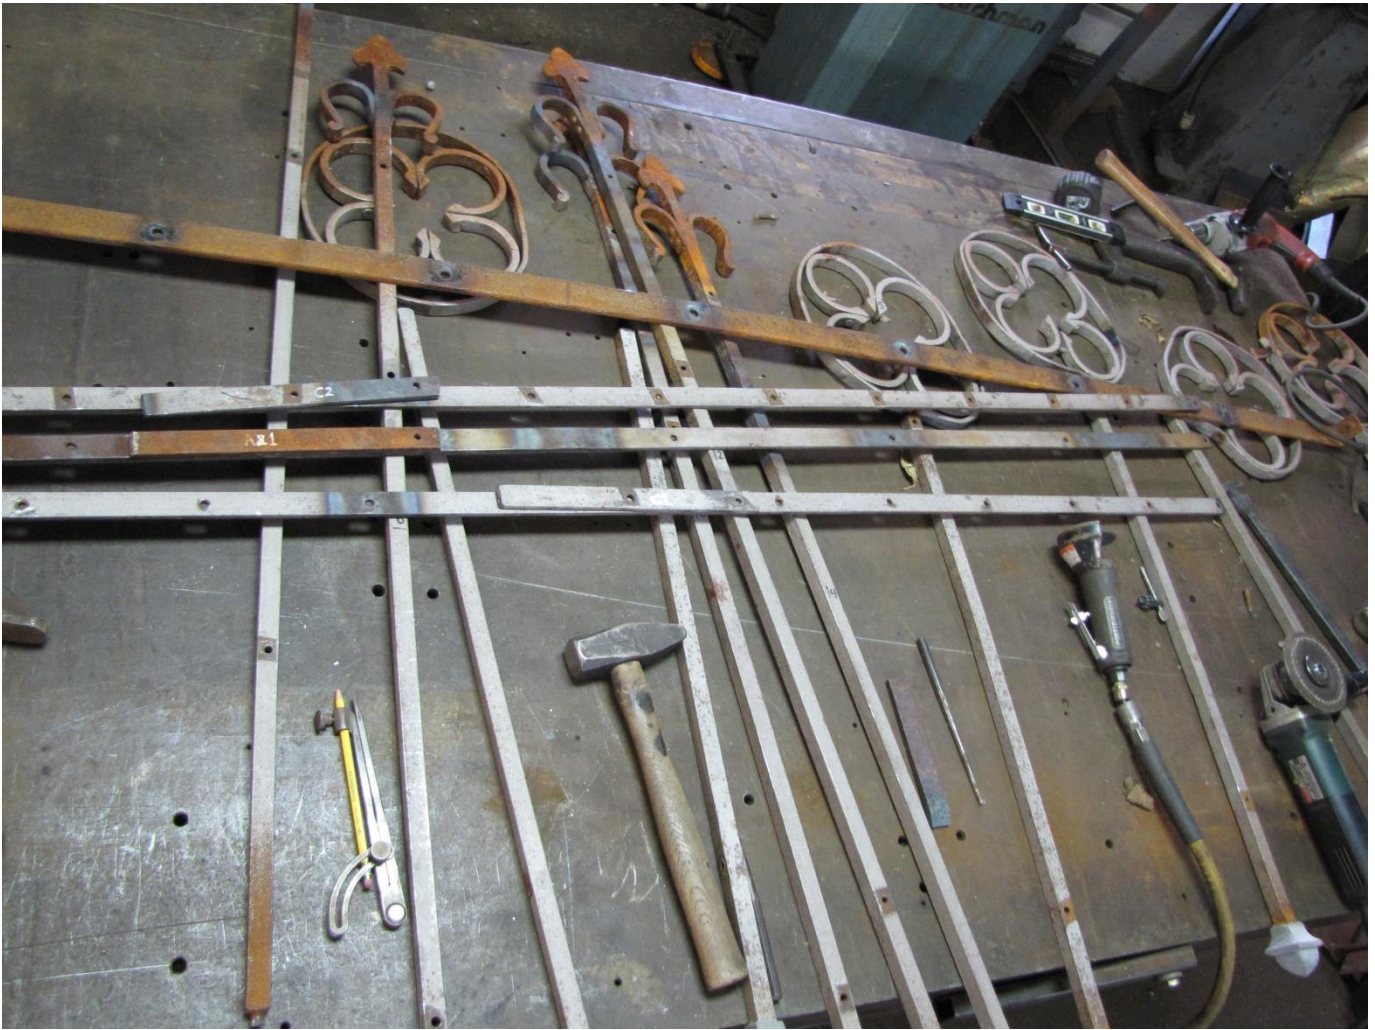
Here is a picture of the fencing after it was removed from the client's estate. Given the fencing's unique handmade quality, no section or post was exactly the same. The restoration process is much like fitting together pieces of a puzzle with no two exactly alike. Therefore everything had to be carefully assessed and cataloged before removal. In addition, much of the ironwork showed significant corrosion due to its age. This is very common in historical ironwork that is not regularly maintained.
