## The Restoration of the Henry Street Settlement Exterior Ironwork

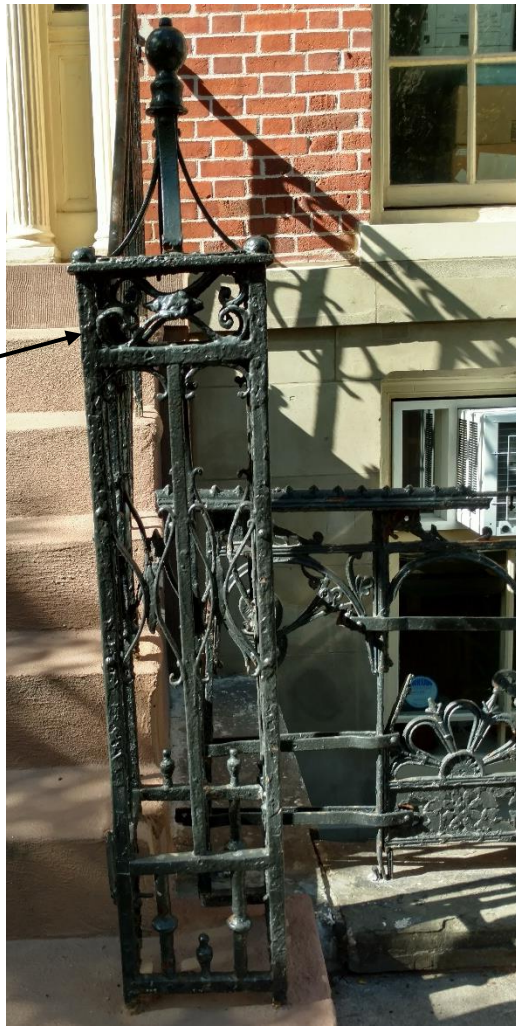
Hand forged scrolls  
made from genuine  
wrought iron

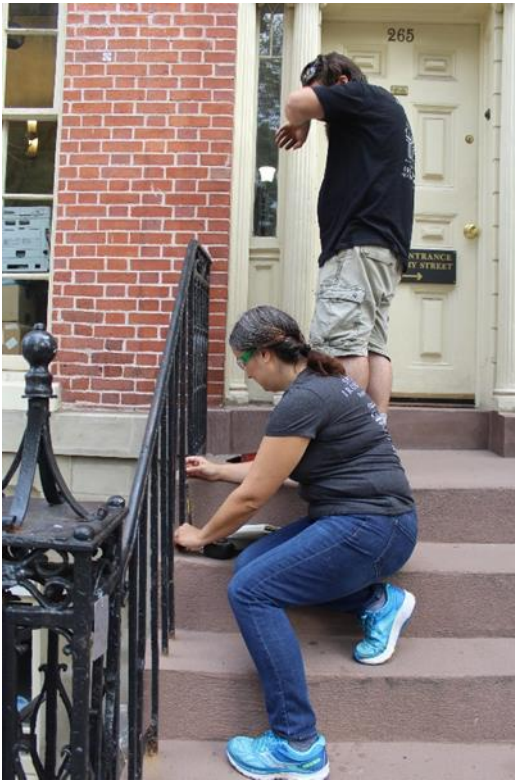
Right Entryway newel post and railing  
section at 265 Henry Street.

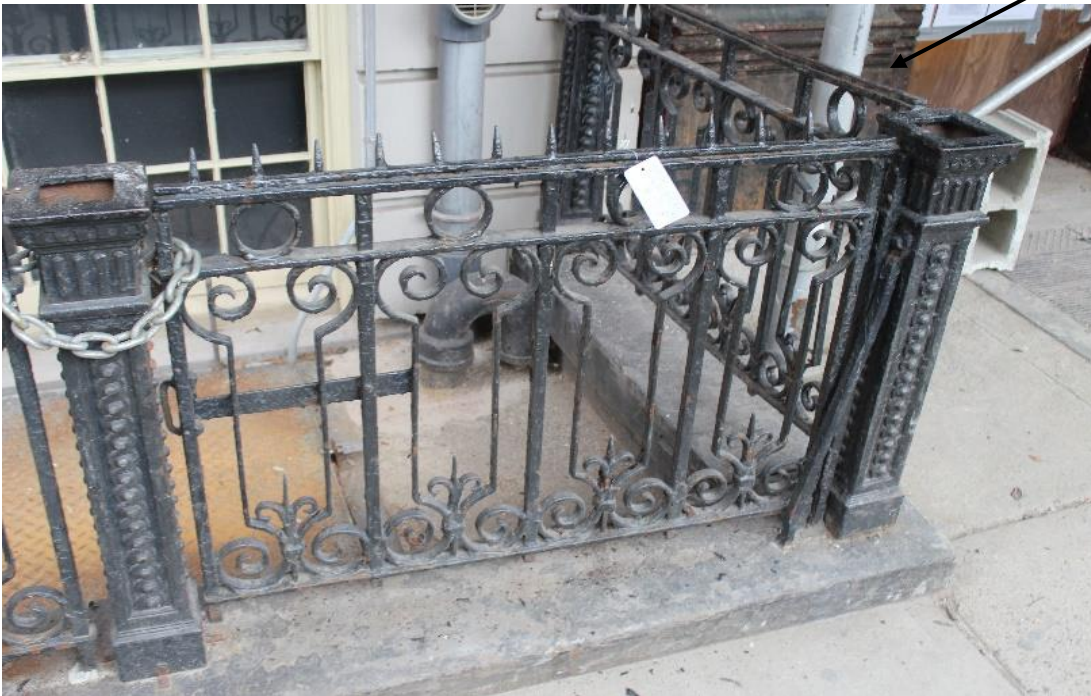
The damages to the original loafer railings sections were extensive. We removed 5 sections in need of restoration. The top bars were badly bent out of shape and some of the spikes were either damaged or missing. In addition to the 5 damaged sections, we noted a railing section whose loafer rail was missing entirely. This railing section was particularly interesting as we noticed that the bottom fleur de lis scrollwork was quite worn-down displaying that they had bared both weight and friction for some time. It became evident that the spikes were purposely removed so that the railing could be sat upon while the scrolls were used as footrests.

Missing entire loafer rail.

The restoration of the loafer rails found outside of 267 Henry Street was an involved process. The initial step was to straighten the badly bent top bars by heating them at our forge and straightening them with a hammer. The missing top bar was remade using reclaimed genuine wrought iron that was forged and hammered to match the style and dimensions of the existing pieces. The missing spikes were also remade using genuine wrought iron. The images below illustrate this process. They show our blacksmith cutting and shaping each spike to match the original forms. Once made, each spike was passed through the openings of the top bars and forge welded into place. This method of recreation was very much in line with the original method of construction during the 1830s.

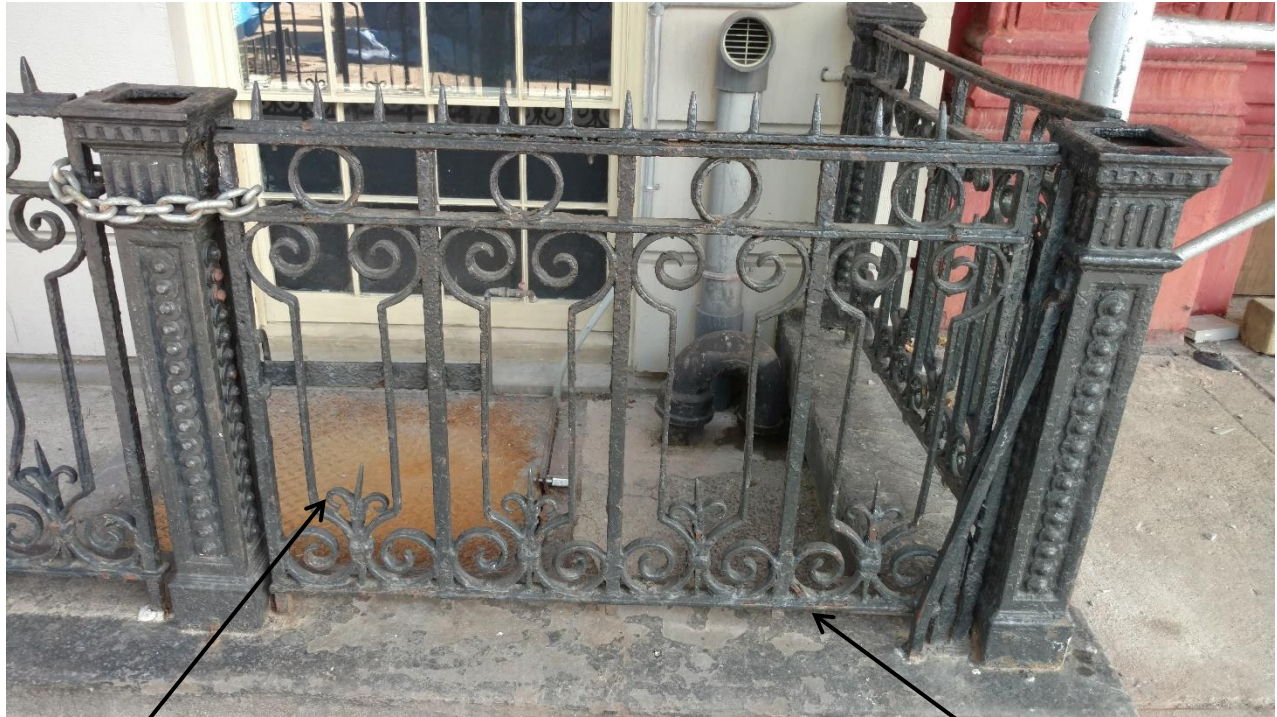
During our initial assessment, we found the railing panels outside of 267 Henry Street to be mostly intact. Though quite weathered, the panels still displayed the artistry and craft found in 19<sup>th</sup> Century American ironwork. Although the panel sections were missing few parts, the components found throughout the design were badly bent and misshapen. This included the horizontal and vertical lines that make up the framework structure of the fencing sections. In addition to the warpage, much of the ironwork showed signs of rust and corrosion caused by the many years exposed to outdoor elements.

Misshapen Original Components

Heavily Corroded Area

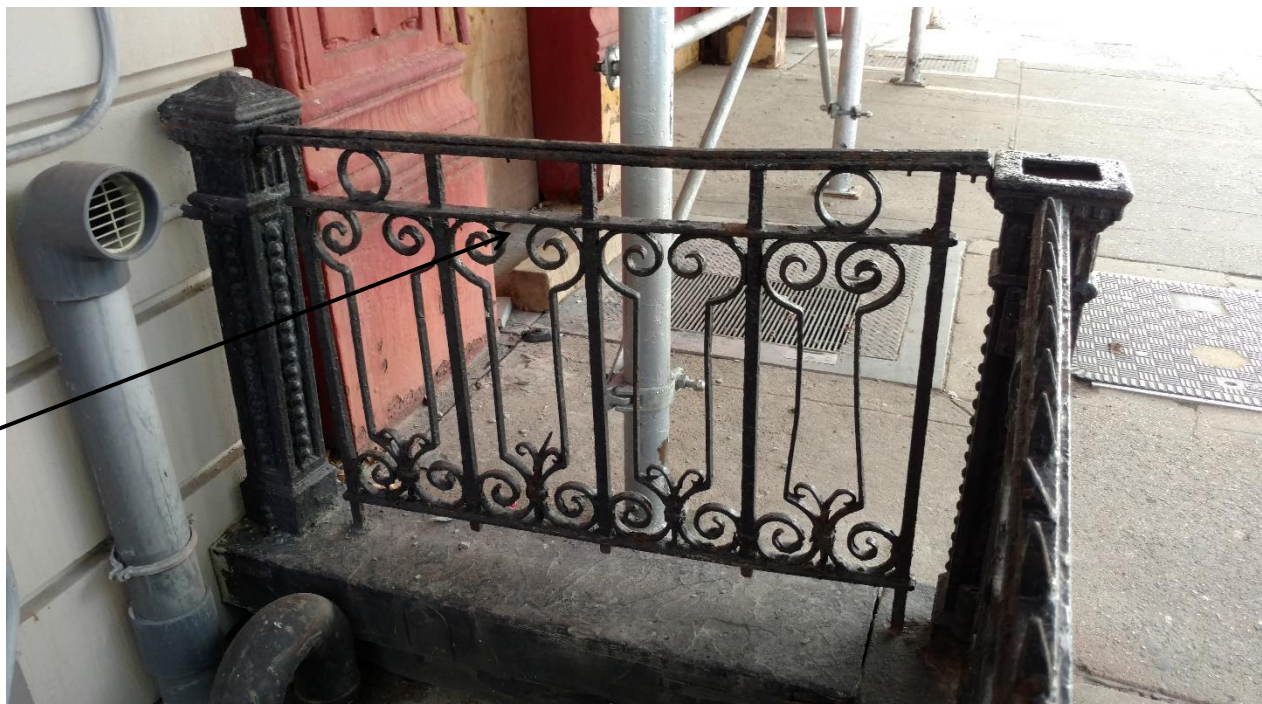
Bent and  
Sagging  
Horizontal  
Line

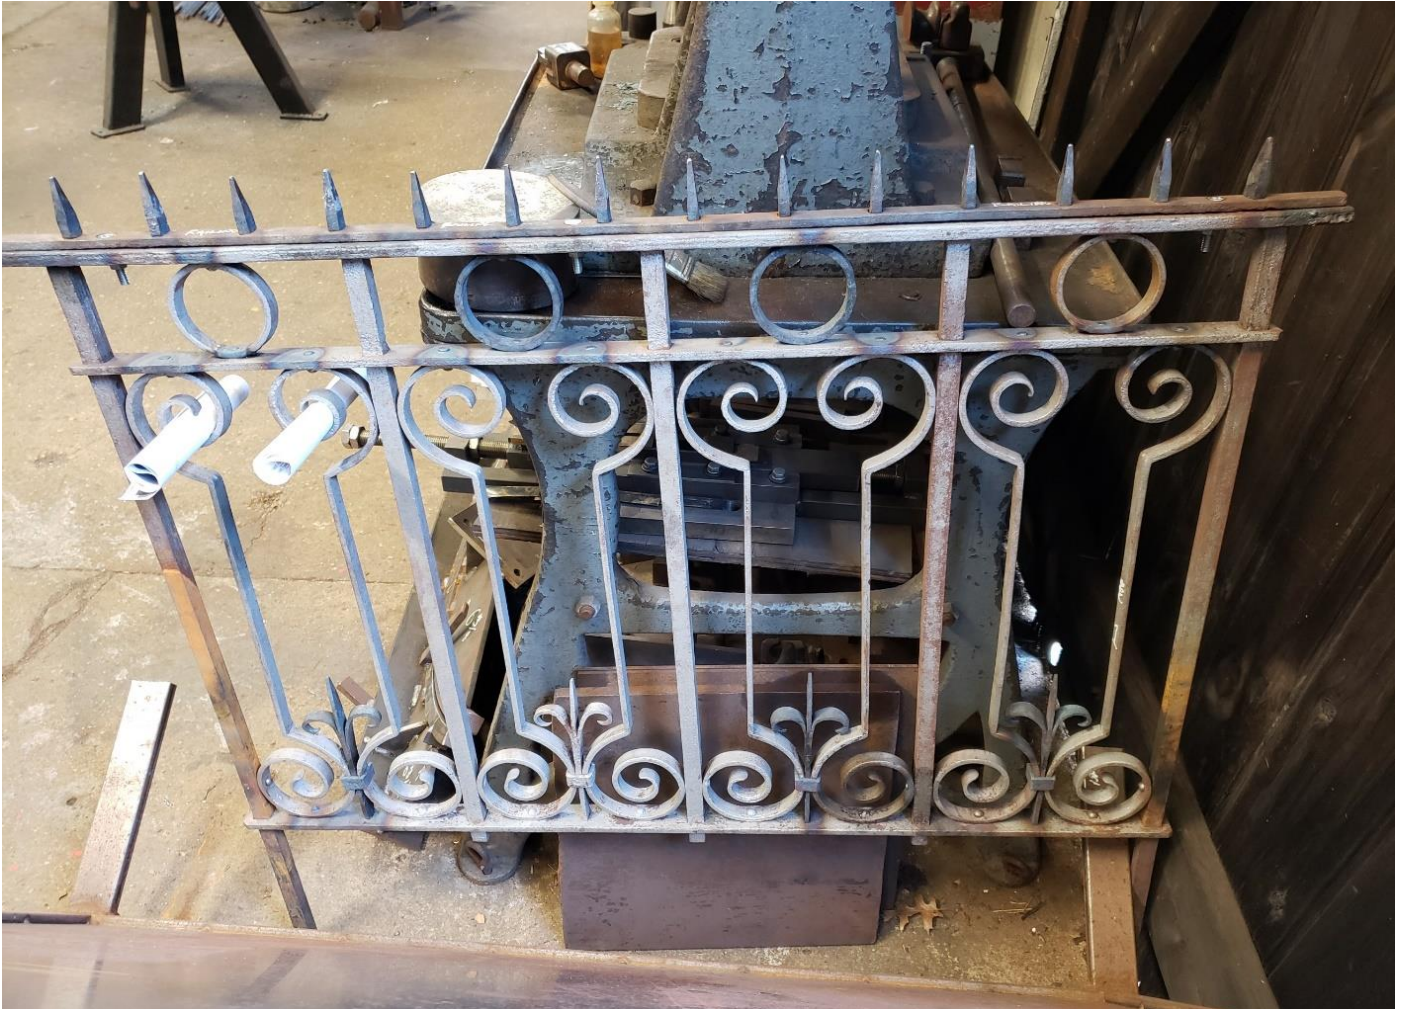
Below is an image of a restored fencing section, before receiving its final rust-proofing and paint applications. All the rust has been removed and deteriorated areas have been repaired or replaced. The distorted curves found throughout the scrolls and bottom fleur de lis components have been reshaped back to their original flowing appearance. It is important to note that the craftspeople of this era were much more concerned with the beauty, harmony and appropriateness of the design, than the precise regularity of the finished product. It was by the hands of these very artisans that made each piece so special.
