Restoring New York City's Historical Ironwork

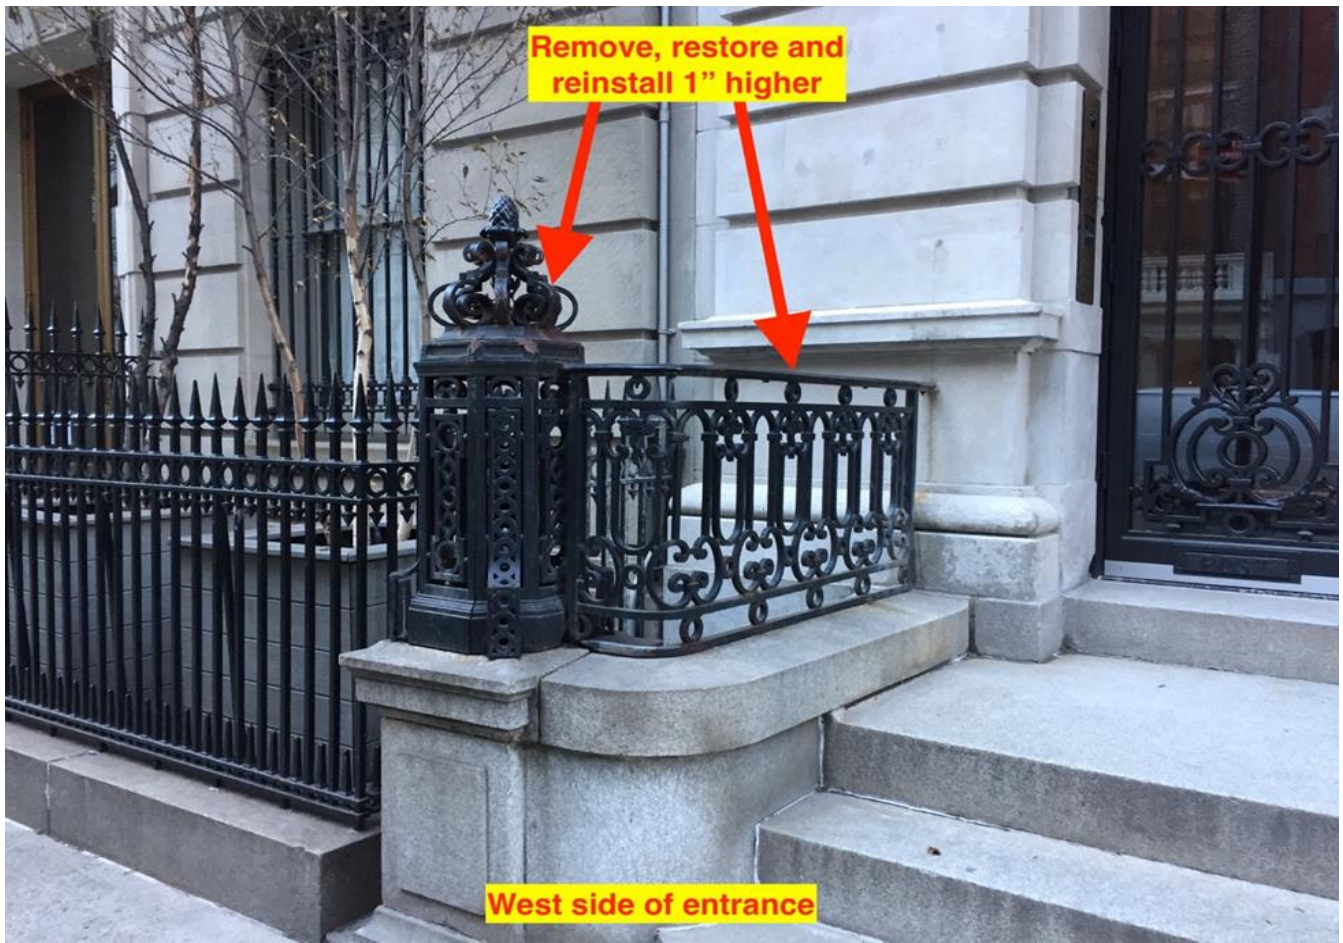
Here, you can see the original scope of work that was needed to restore the original ironwork. The plans were provided to us by the G.C. and required by the client and the New York City Landmarks Preservation Commission.

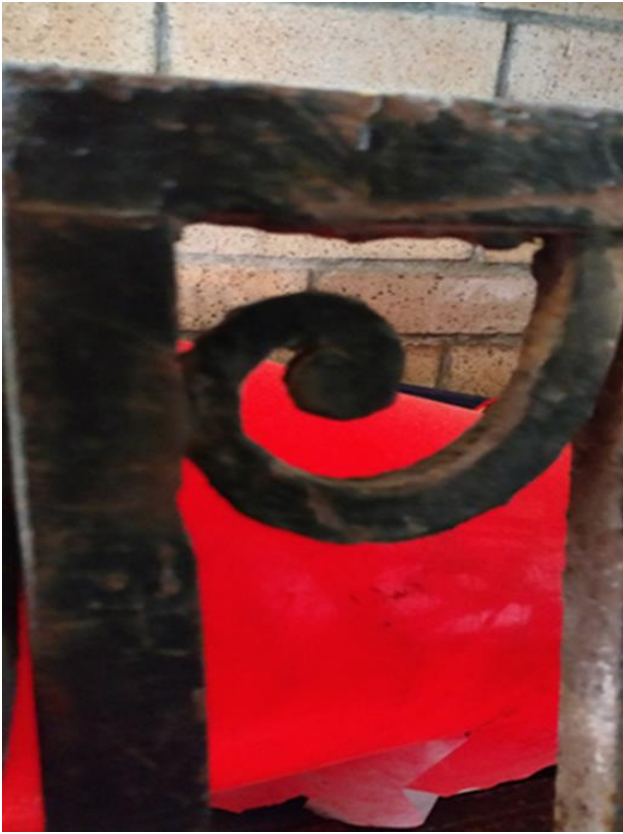
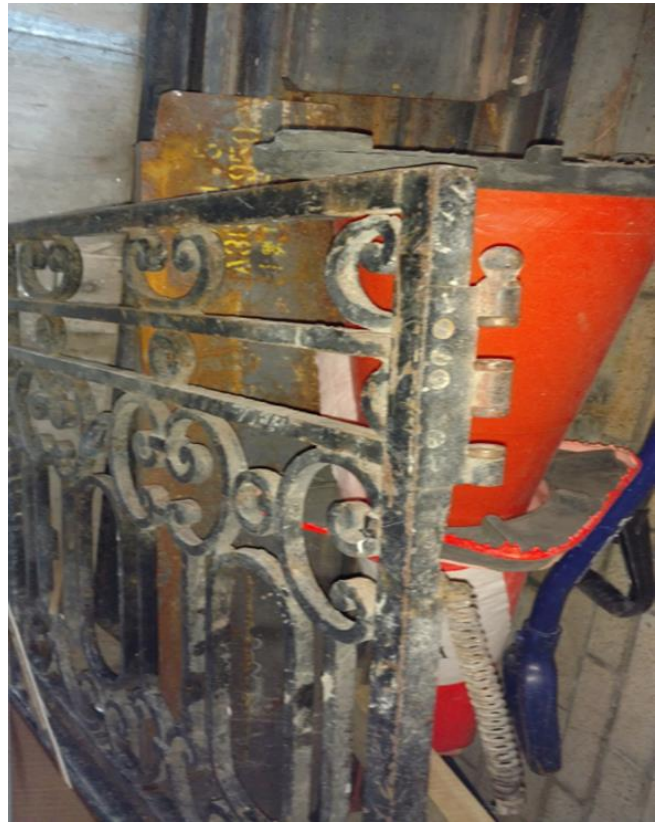
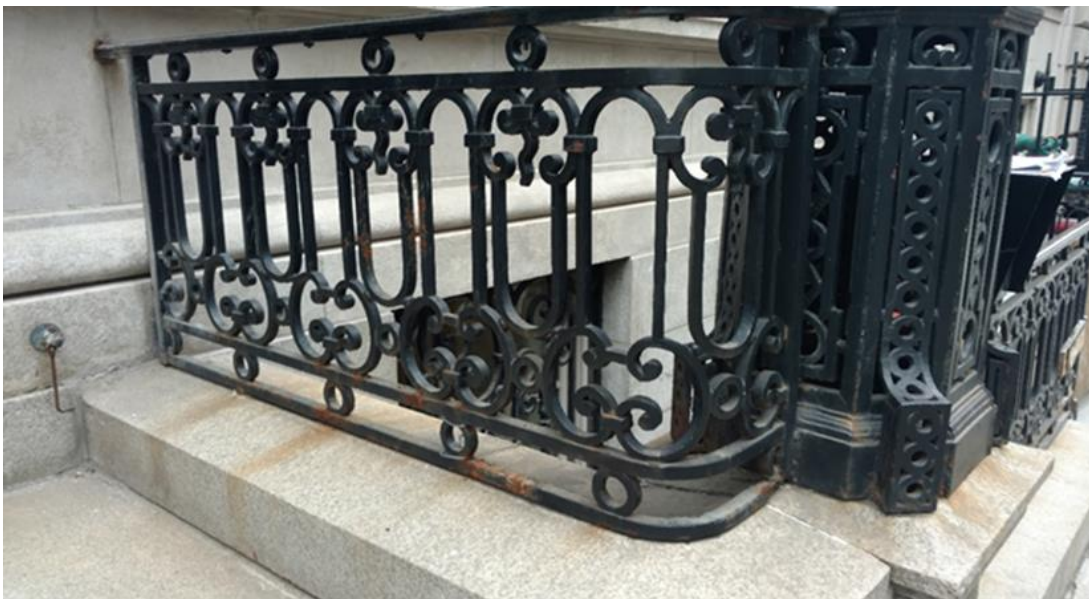
These images illustrate a portion of the corrosion and damage found throughout the ironwork. We also discovered marks of an earlier restoration which was poorly executed. We would have to redo the previous work to restore the ironwork to its previous glory.

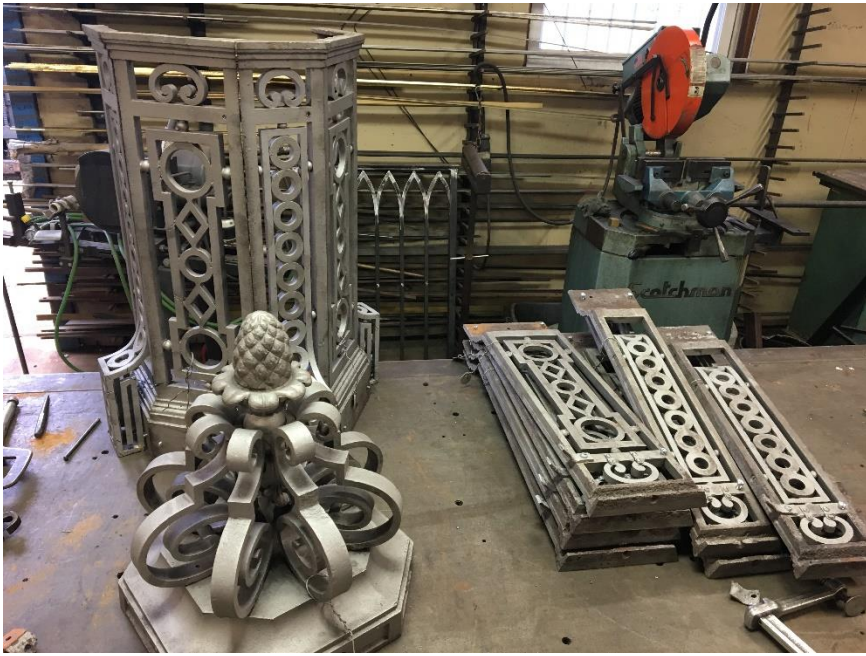
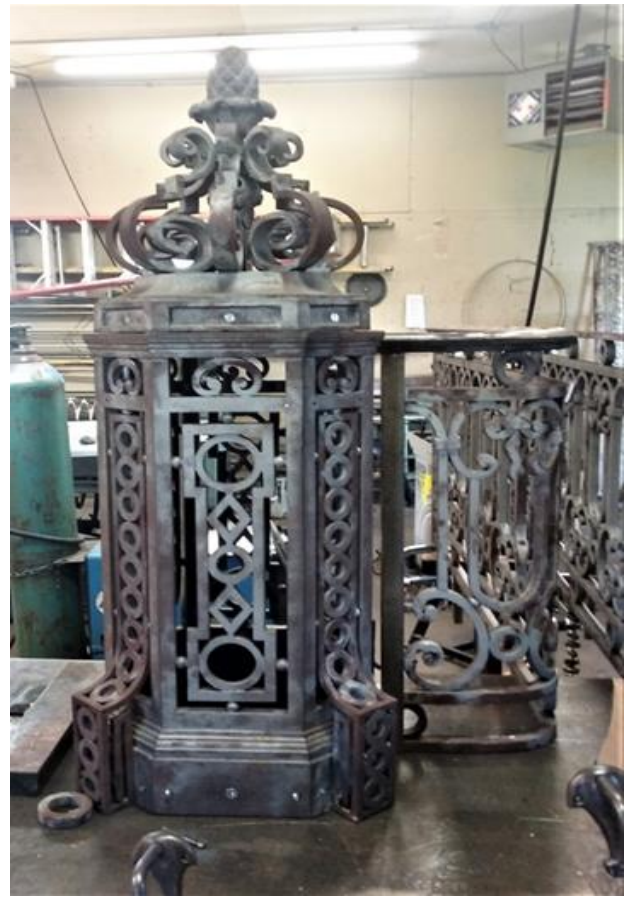
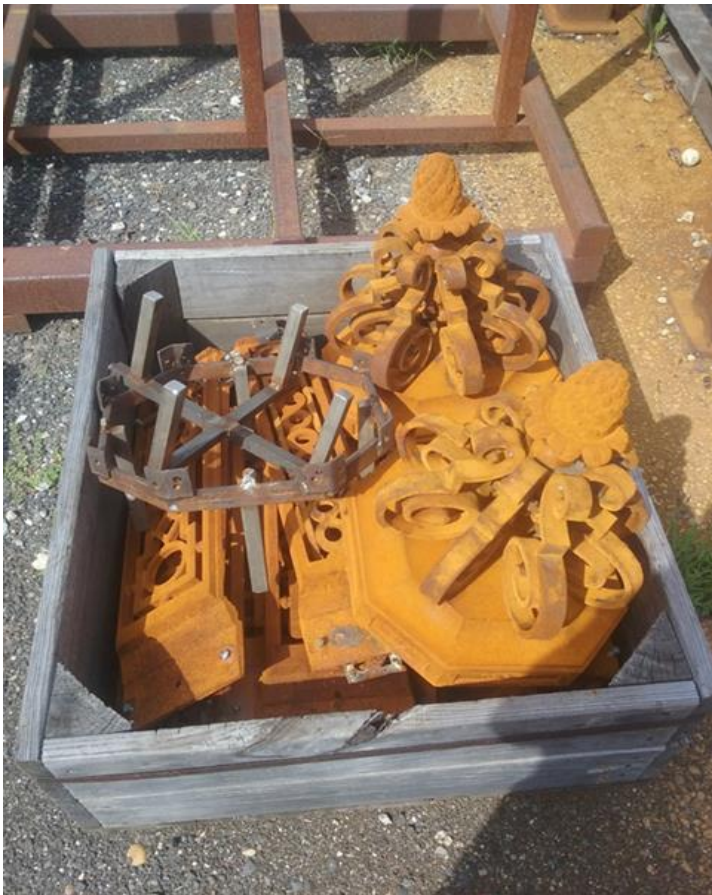
At first glance, the assembly of the front entry posts looked to be simple. Upon closer examination, we realized that this was in fact, not the case. The body of the post consisted of 8 separate decorative panels attached together. The top of the post was also a separate piece with an additional 8 scrolls attached together to form its decorative cap. Luckily, much of the structure was fastened together mechanically. Although it was easily taken apart, it proved to be a time-consuming task. Each post would have to be completely disassembled to restore the deteriorated portions of each panel found within the octagonal structure. In addition to restoring the body and cap of the post, we added a new internal structure to the base. We finished by adding brackets to hold the 8 sides together. Each post took approximately 1 week to restore.

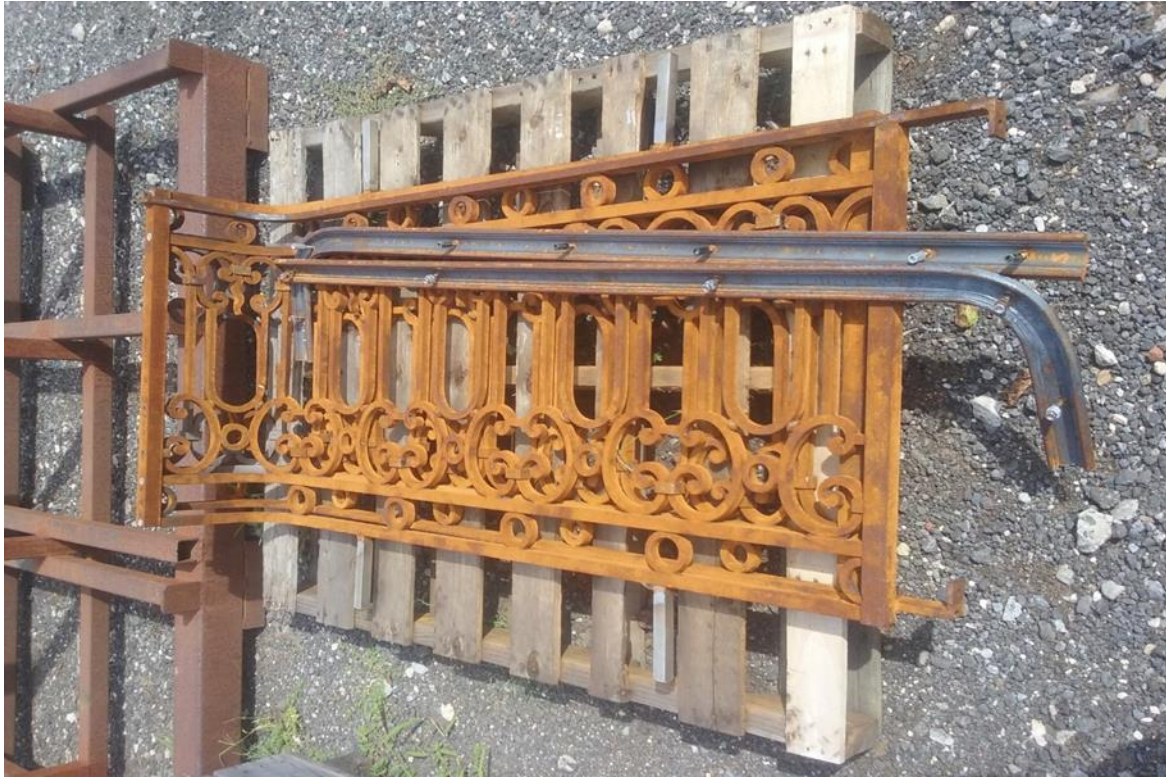
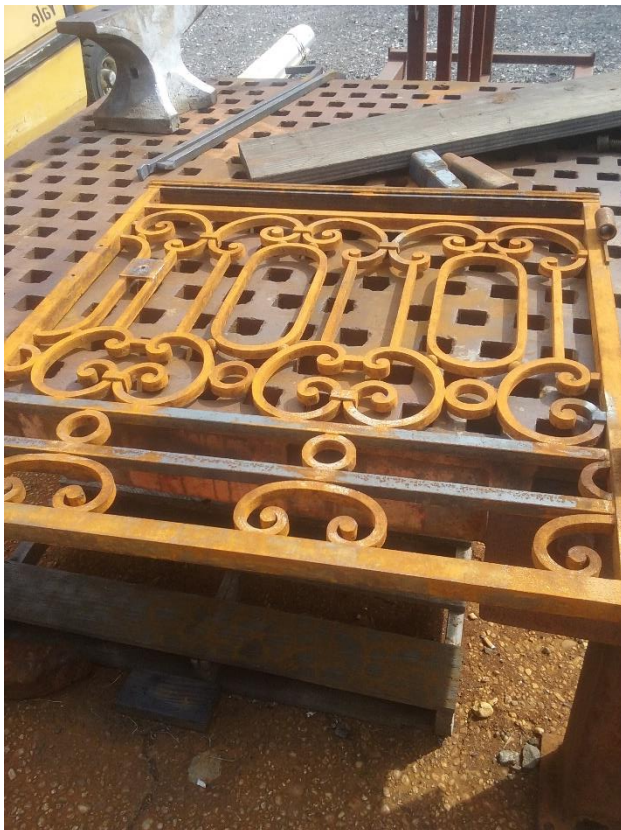
Here are a few images showing the ironwork in various states of repair. The top image shows pieces of additional cap moulding which were custom bent to fit the top of the railings. The gate section (seen on bottom left), was in bad shape. In addition to repairing its existing damaged areas, we re-made areas that were missing and/or too damaged for restoration. Finally, we replaced the original hinges and steel gate latch with custom ones made at our studio.

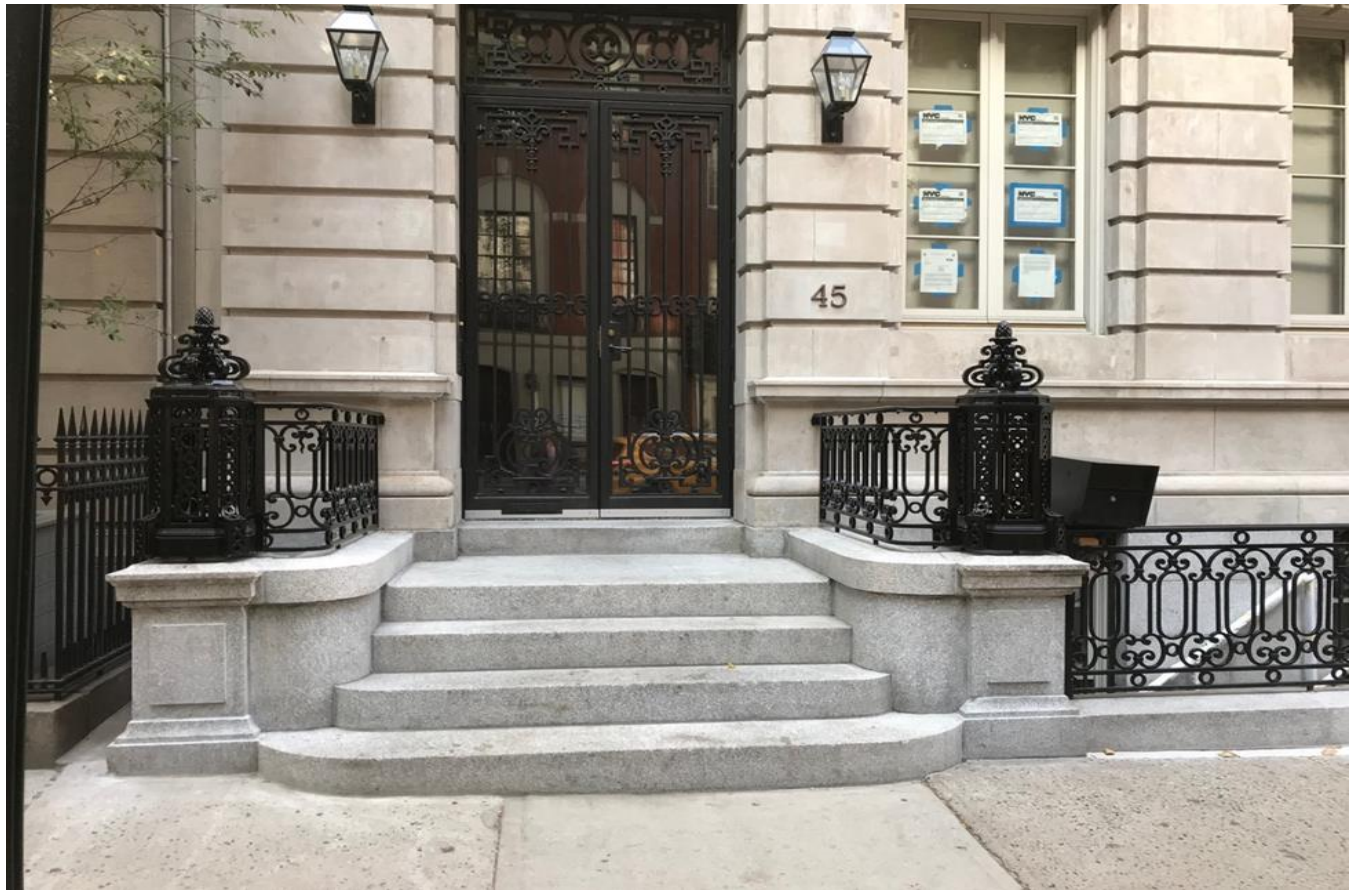
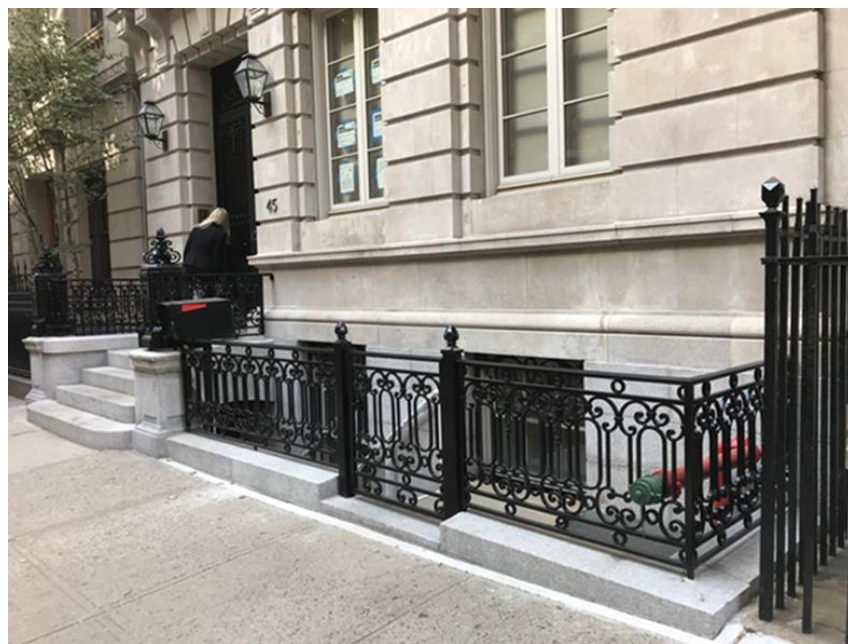
Here are 2 images showing the completed restoration. Although there were many challenges found in restoring this Neoclassical styled ironwork, its presence will certainly embellish the beauty of New York City's streets for another 120 years to come.
