Shortly before Thanksgiving, One of our recurring clients; Ralph Lauren, Co. approached us to see if we would like to create an Art Deco styled coat rack. They presented us with this photograph of a hand forged coat rack and umbrella stand as inspiration. This was to be part of their upcoming holiday window display at their flagship store located on Madison Ave.

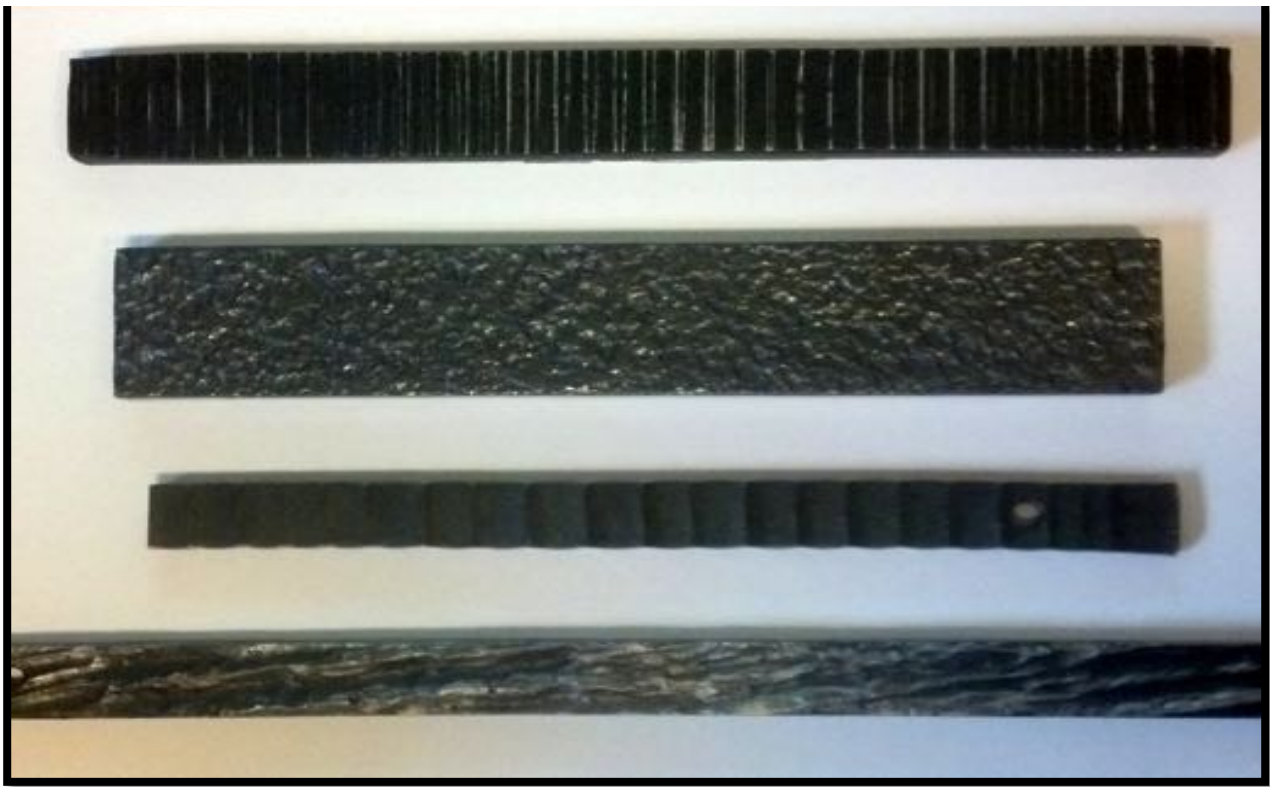
Texture was a key element in the design of the coat rack. During the Deco period, contrasting textures were often used in order to add interest to otherwise simple geometric elements. These samples were sent to the client to show various options that could be used.

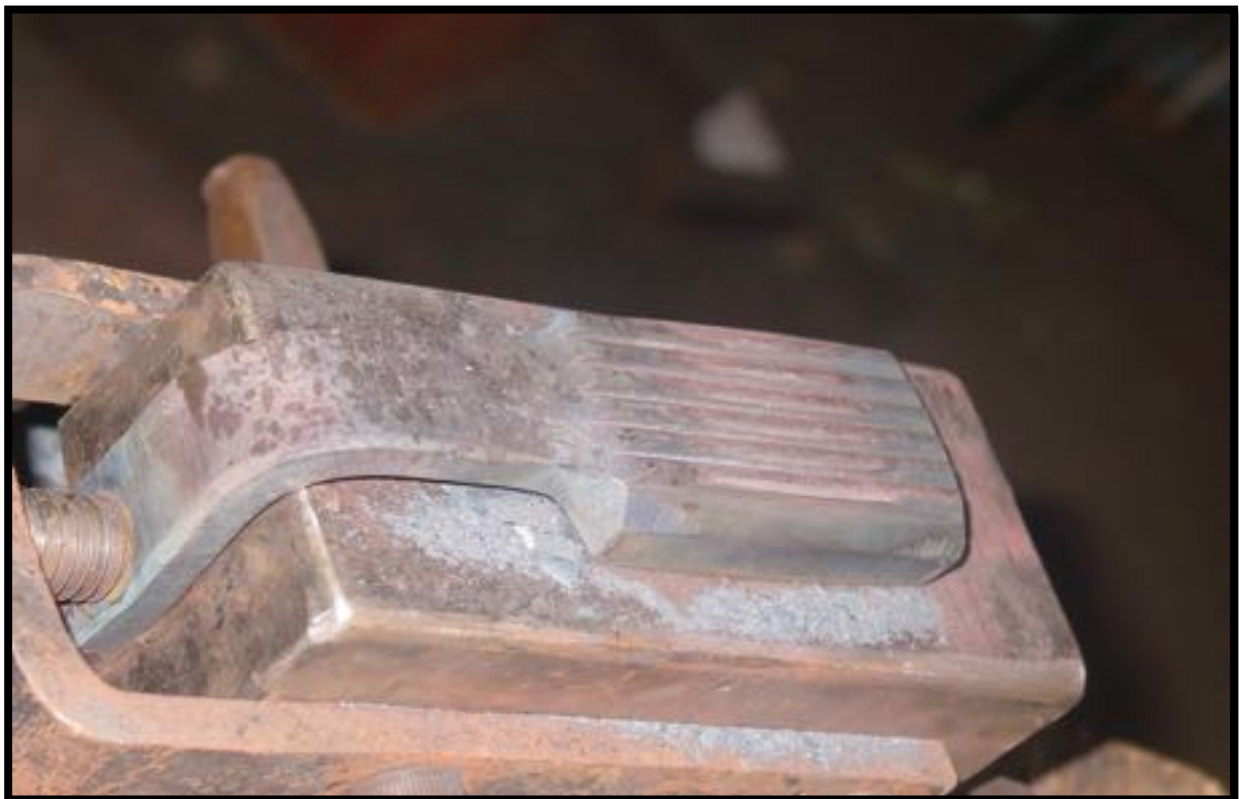
This is a unique tool that we custom made in house to be used in our power hammer. It forged the corrugated texture used in the coat rack. The tool was bolted to the bottom die of our power hammer, a large machine capable of hammering harder and faster than any blacksmith could. The material was heated incandescent and formed by the powerful blows of our big hammer.

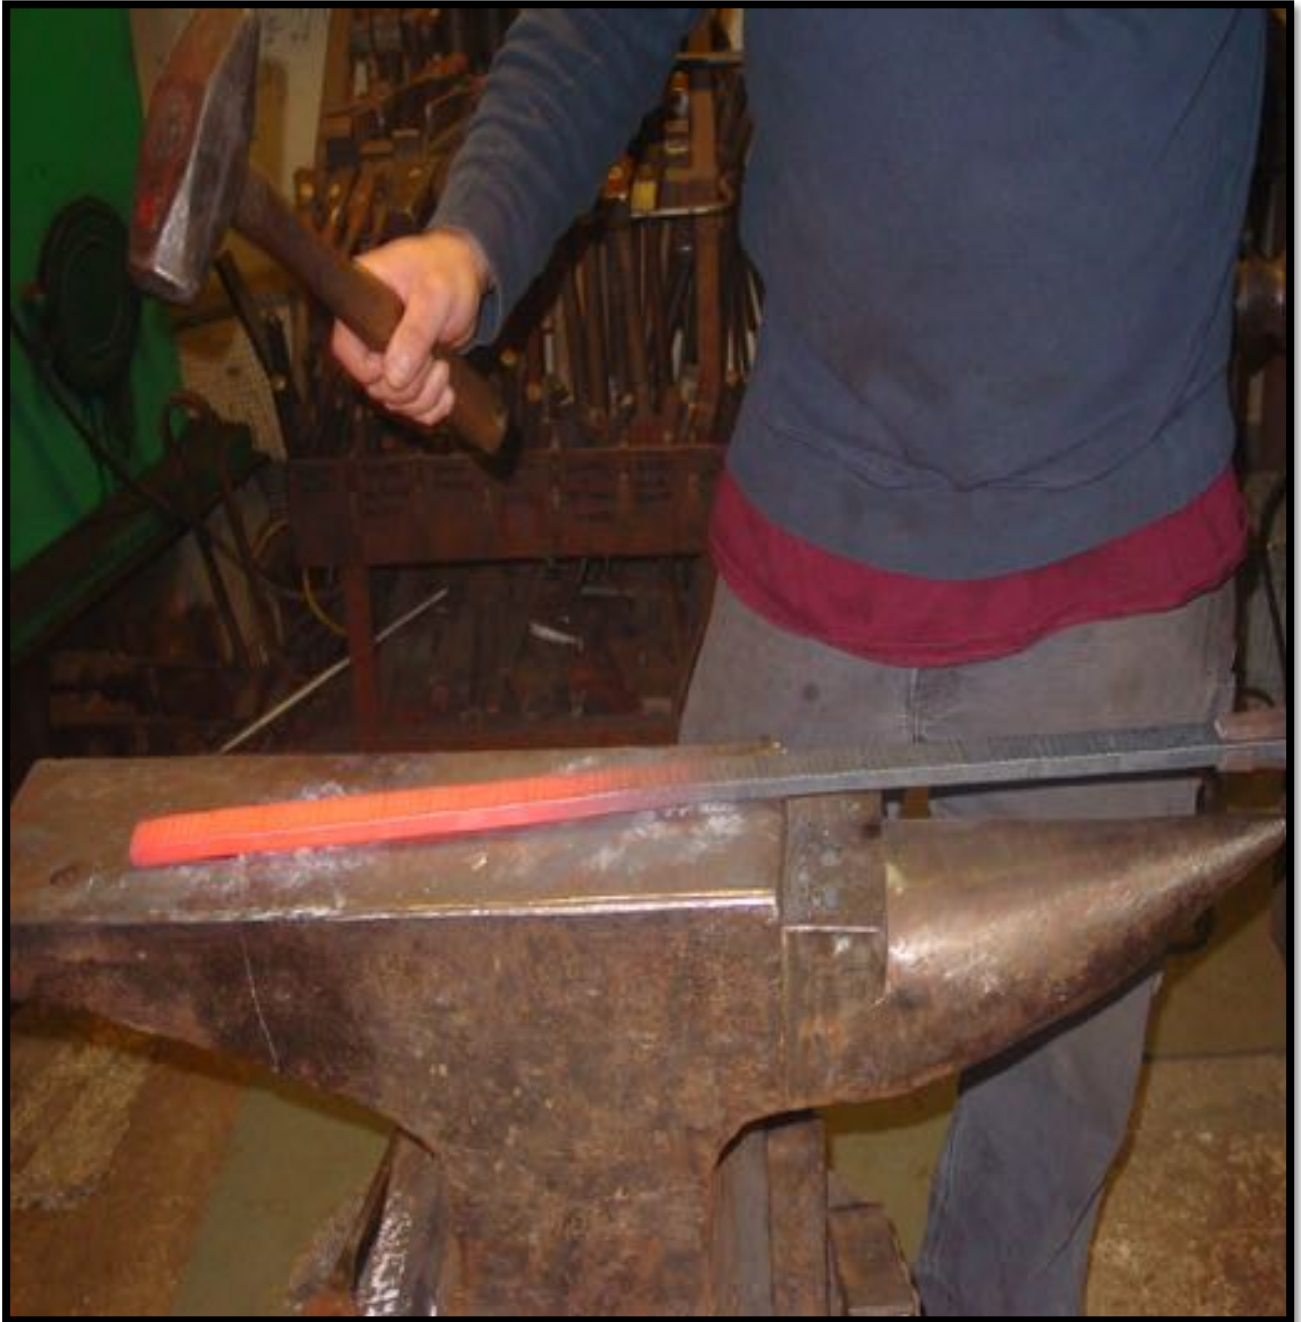
This image shows one of our blacksmiths working on the big shop anvil made in the late 19th century. He straightened the steel bar that was textured in our power hammer with our special tooling.

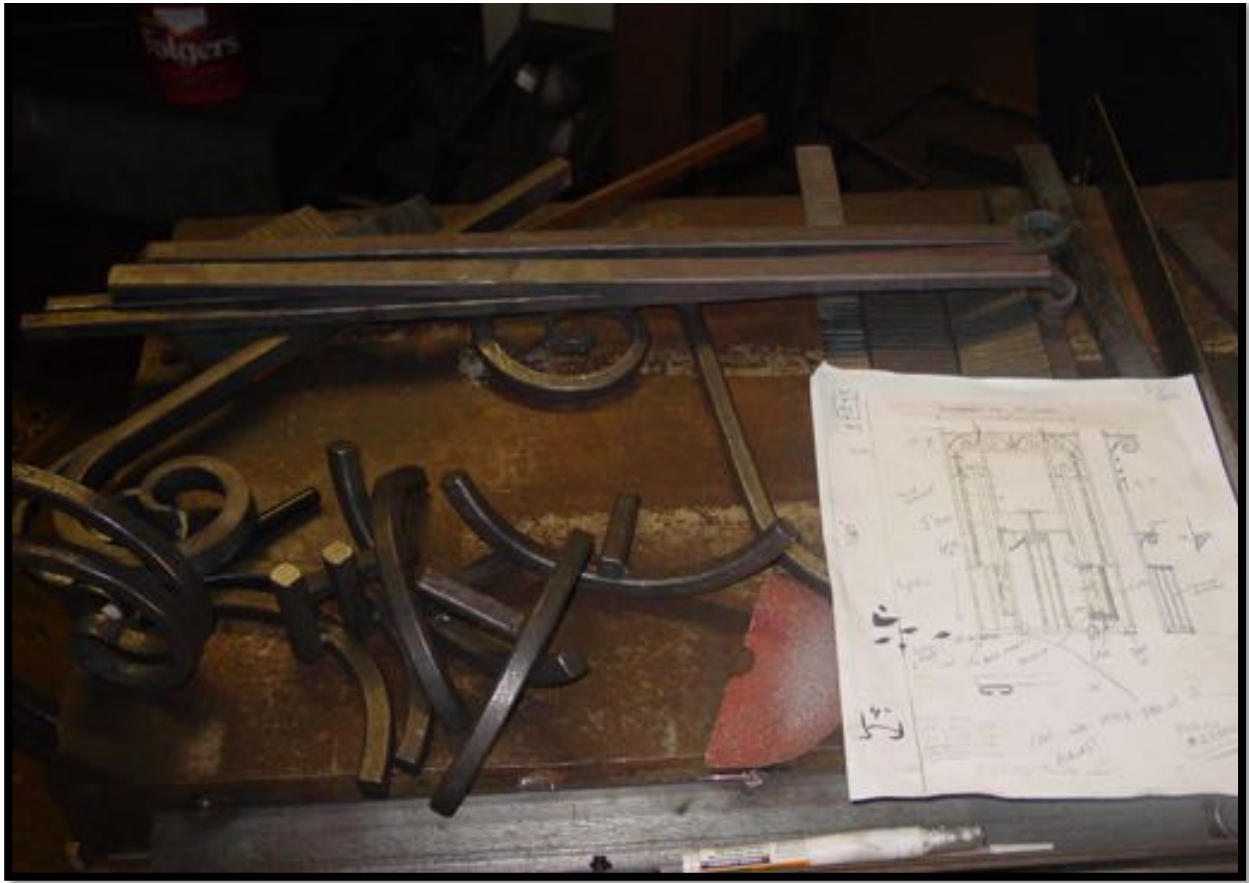
Our smith busily forged parts to be given to the fabricator for assembly all the while carefully checking the drawing as he went along.

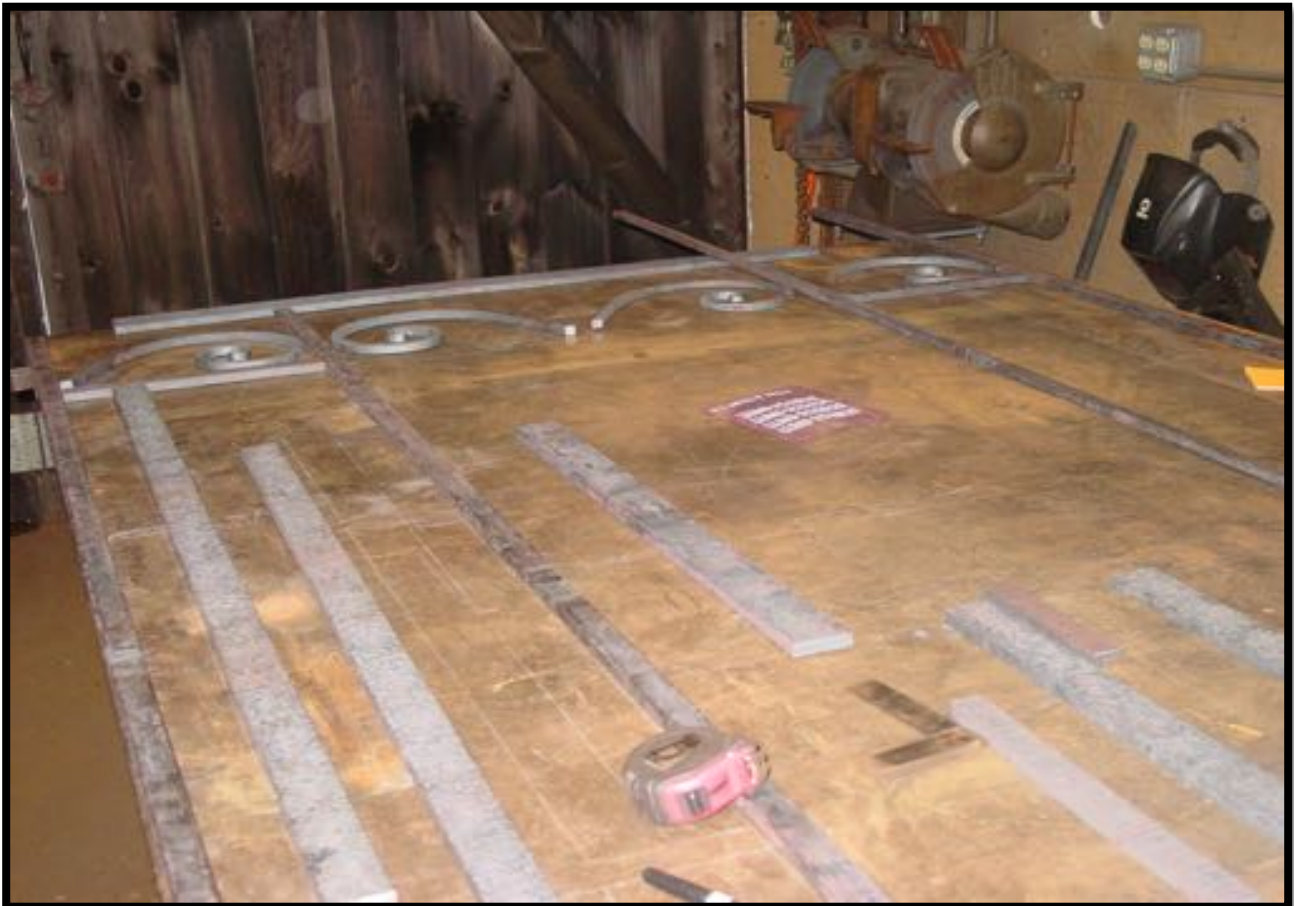
The forged elements were then laid on top of a full sized drawing made on one of our massive steel fabrication tables in preparation assembly.

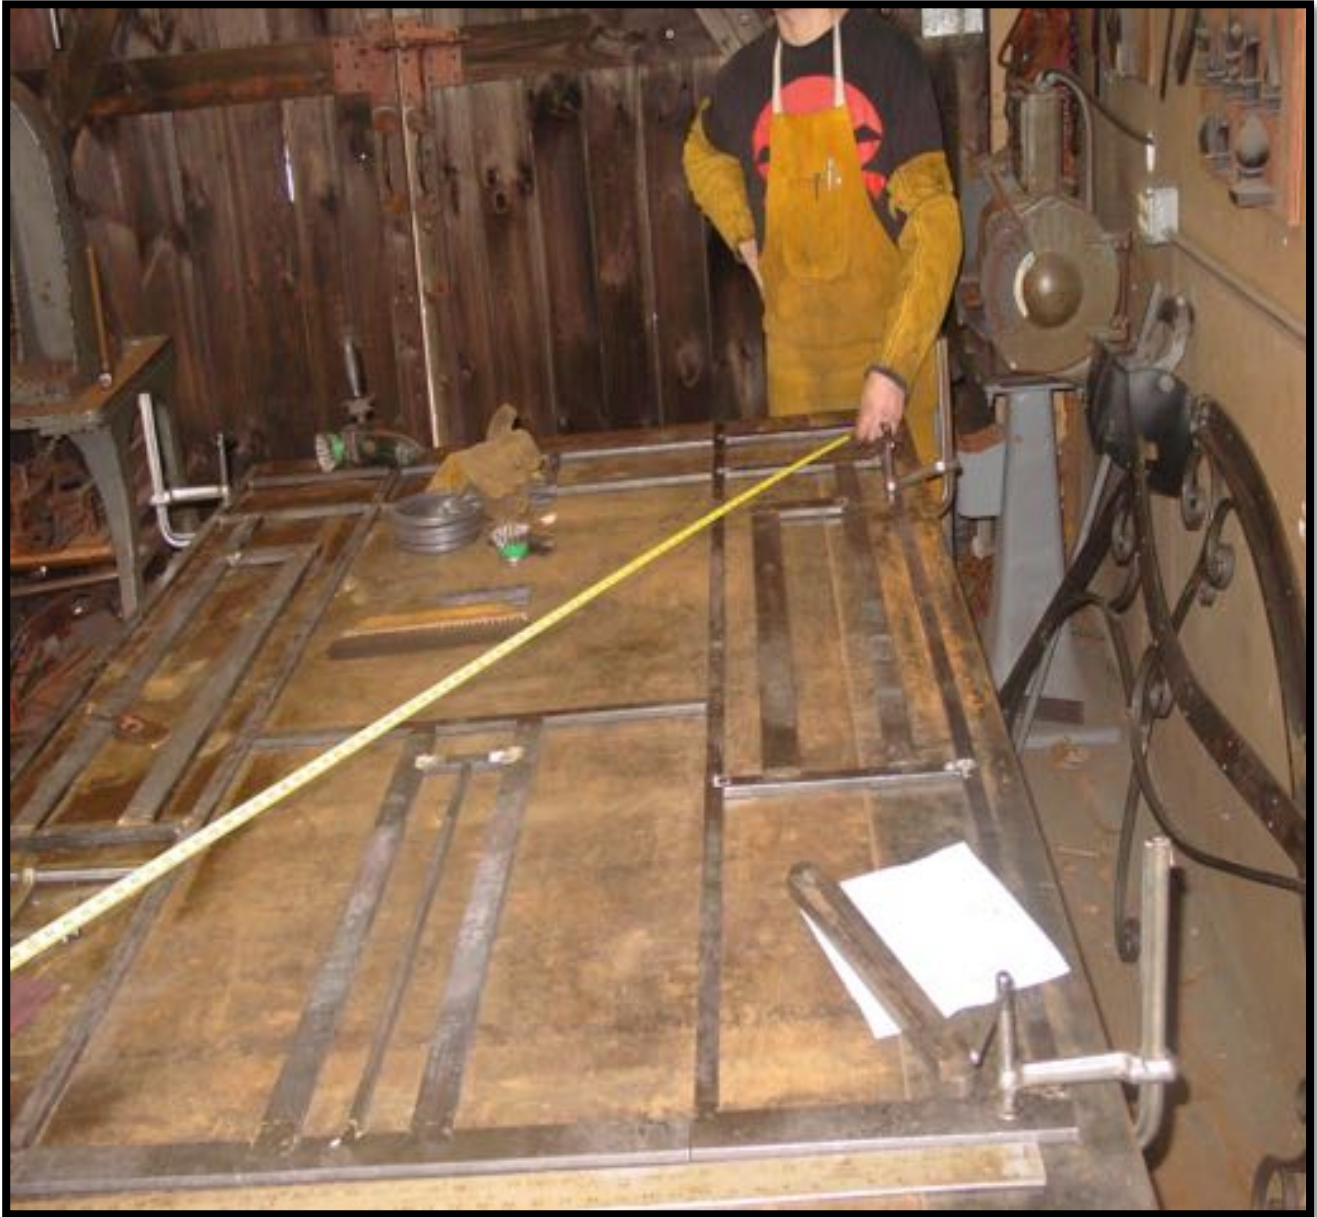
Our skilled fabricator was always checking and rechecking to make sure the work was square, true and made to the right dimension. Parts were clamped in place to make sure the frame did not move while it was being welded.

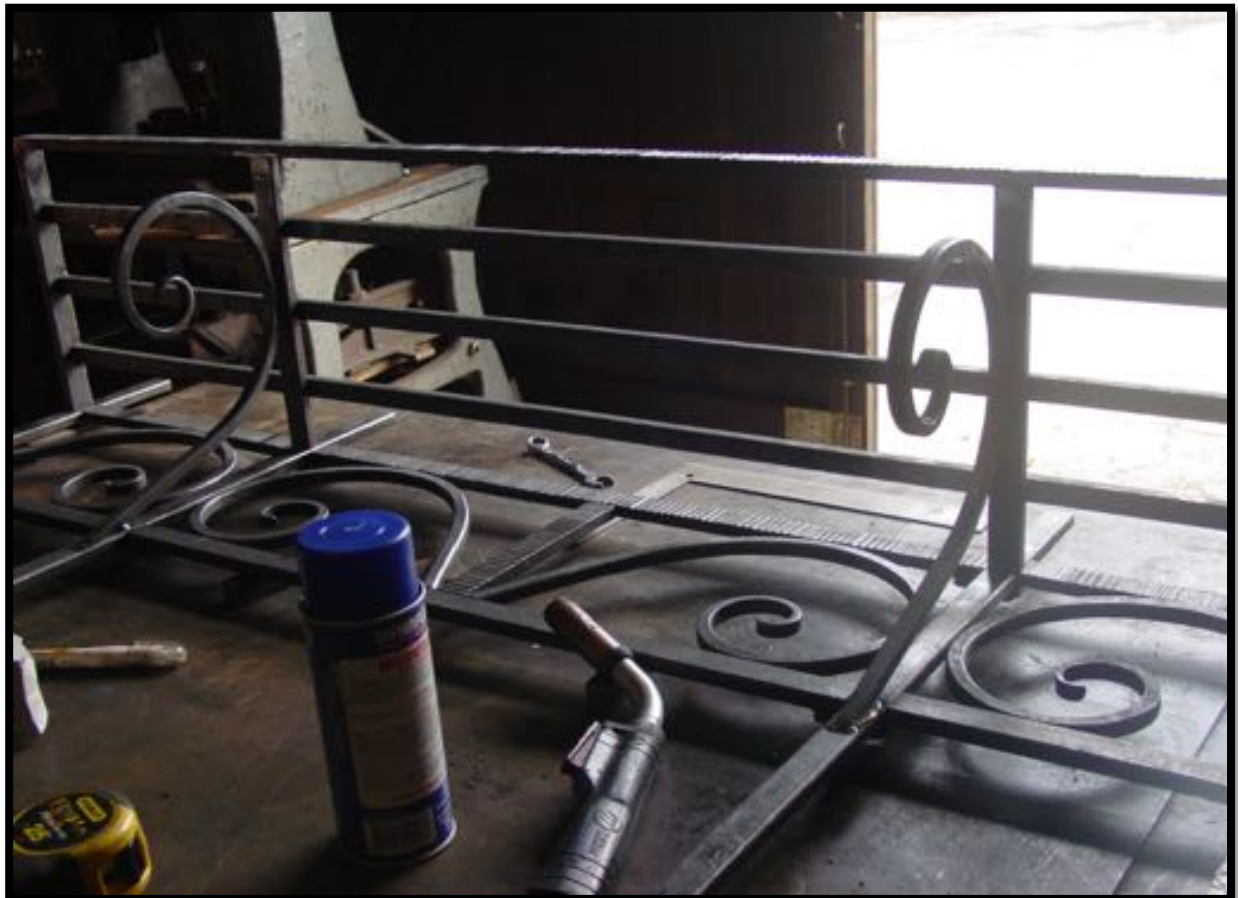
Once the shelf was fitted, scrolls were welded on below to support the shelf and add a decorative element to the overall look of the coat rack.

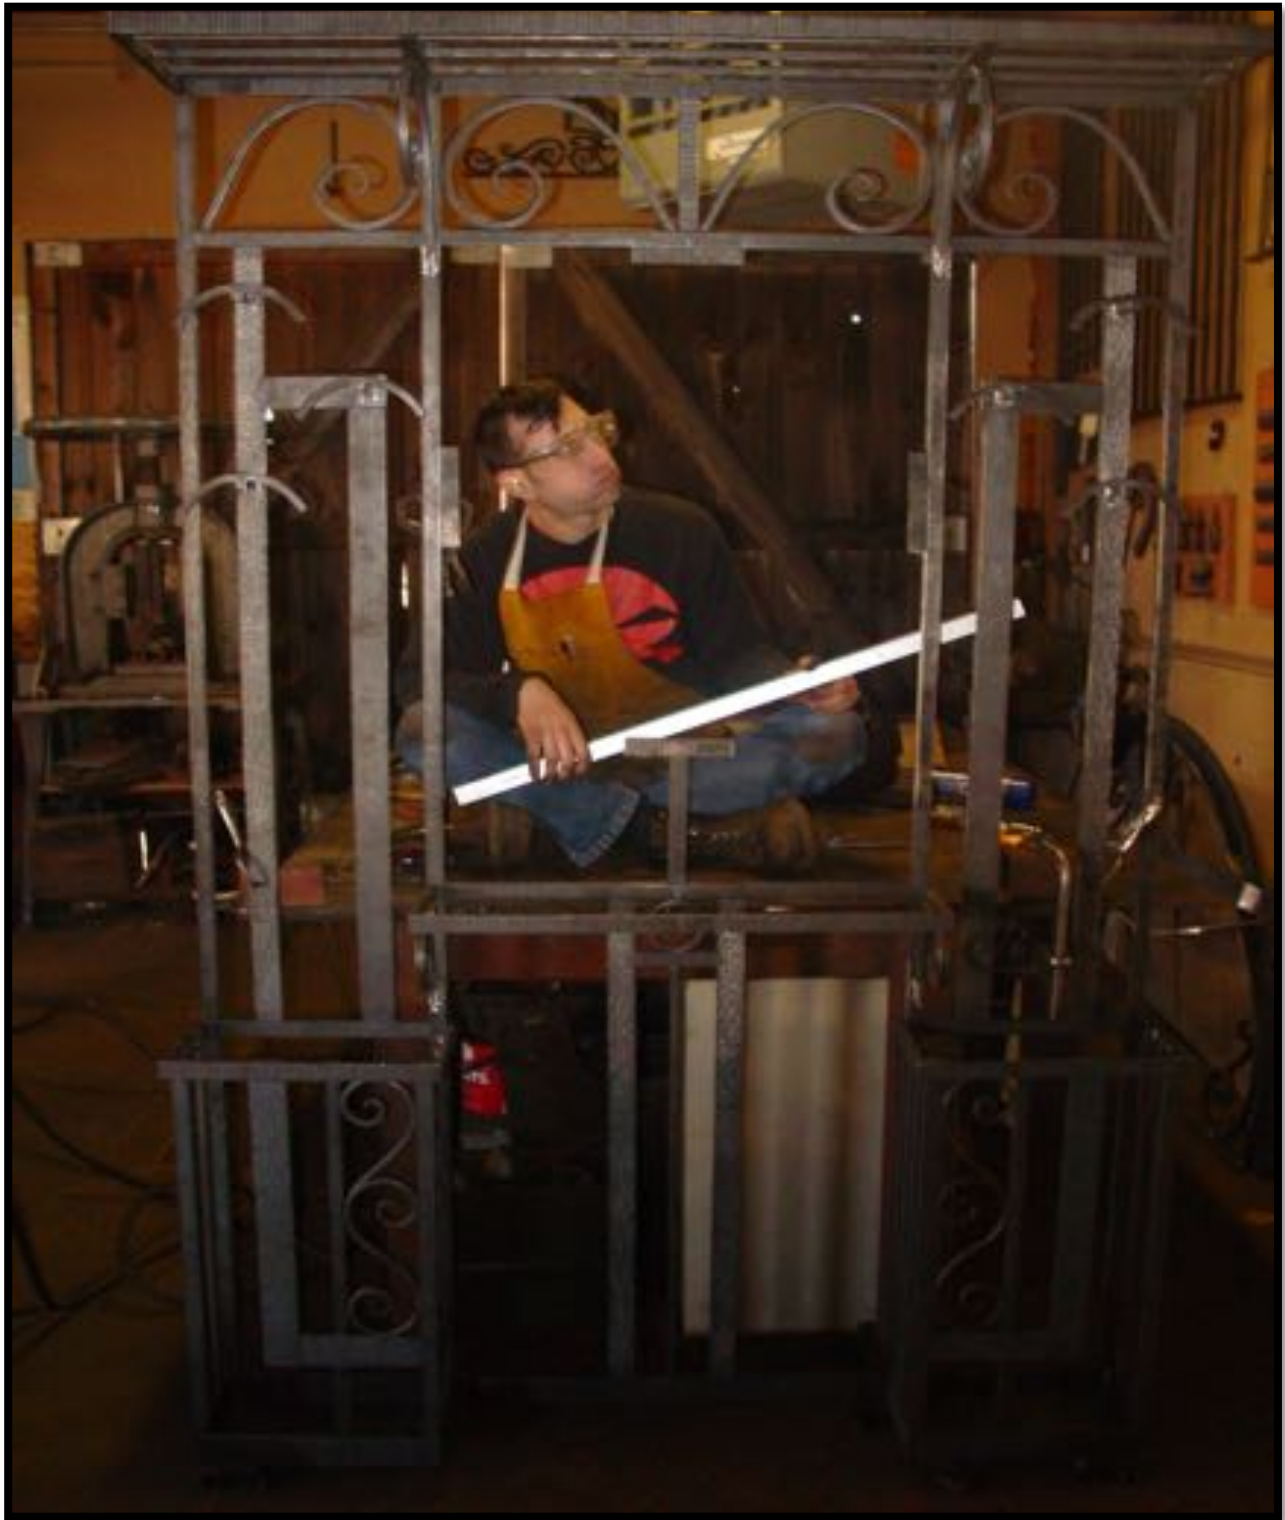
Here is our fabricator tired after a long day of working on the coat rack. This photo shows the piece in its final stage. Lots of overtime was worked in order to meet the client's tight deadline.

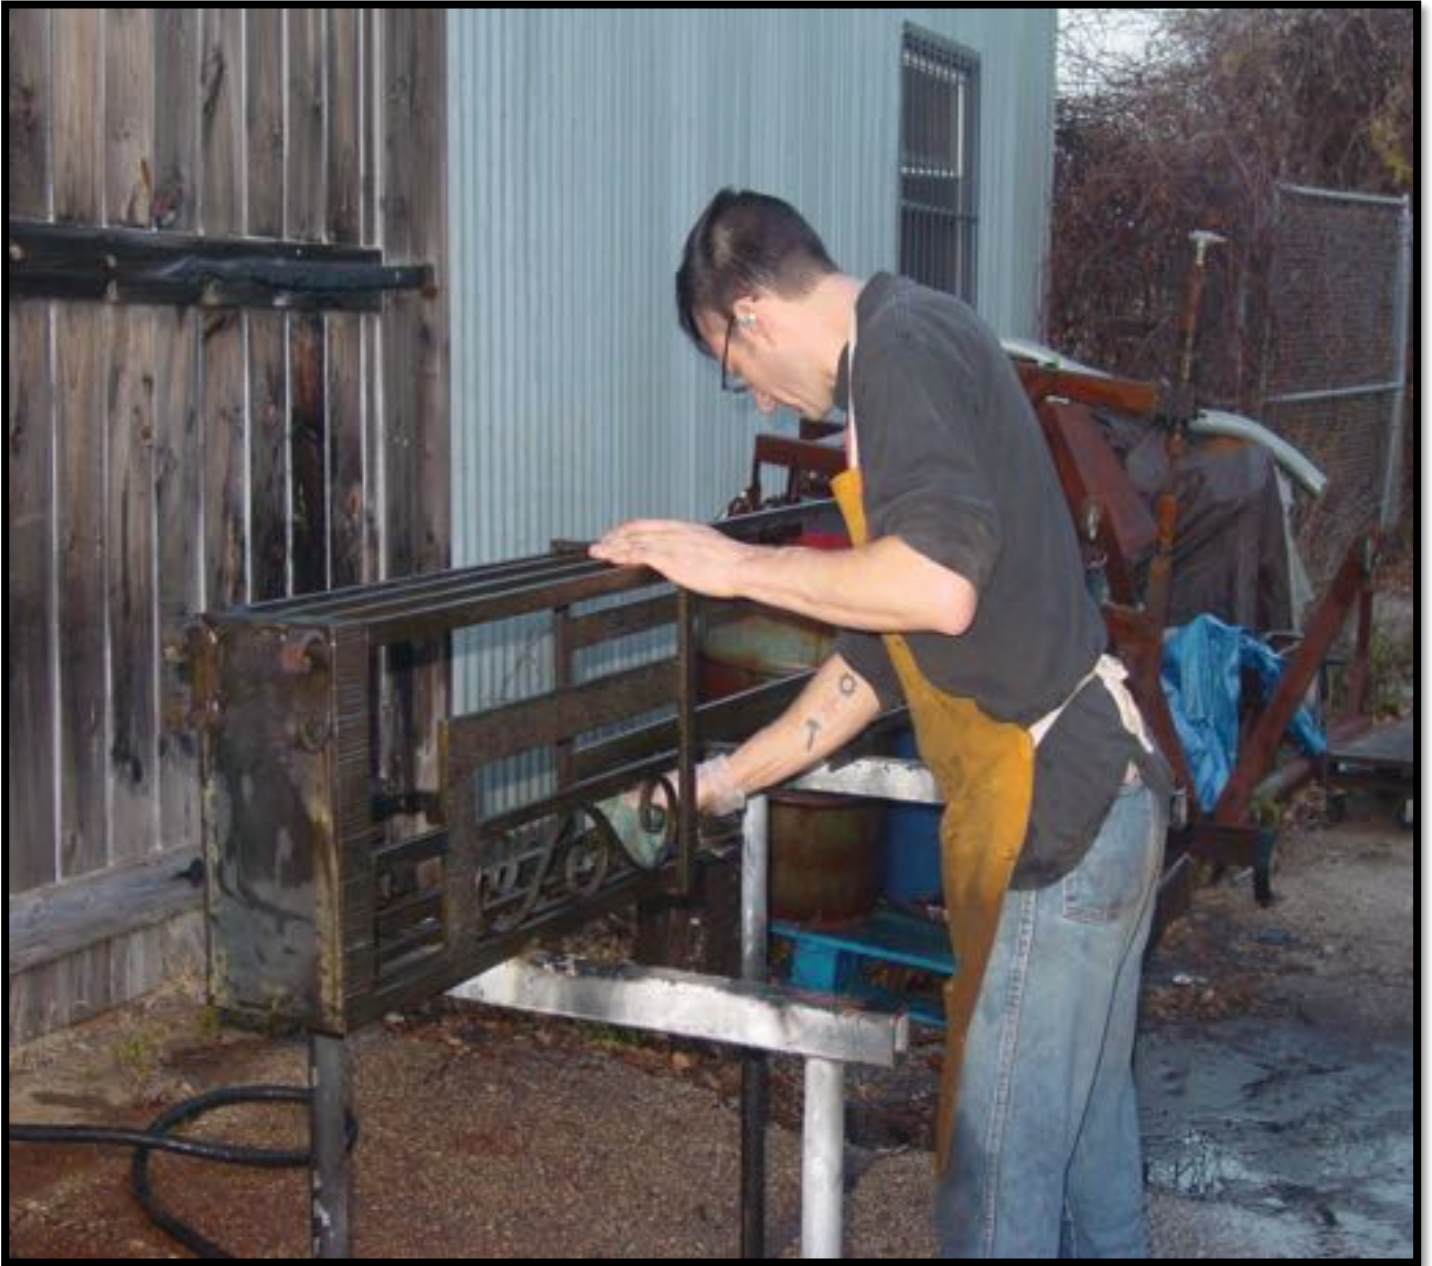
Once fabrication was completed, the coat rack was wire brushed and blackened using a custom patina. The steel was then wiped, rinsed, cleaned and sealed to give it its final look.

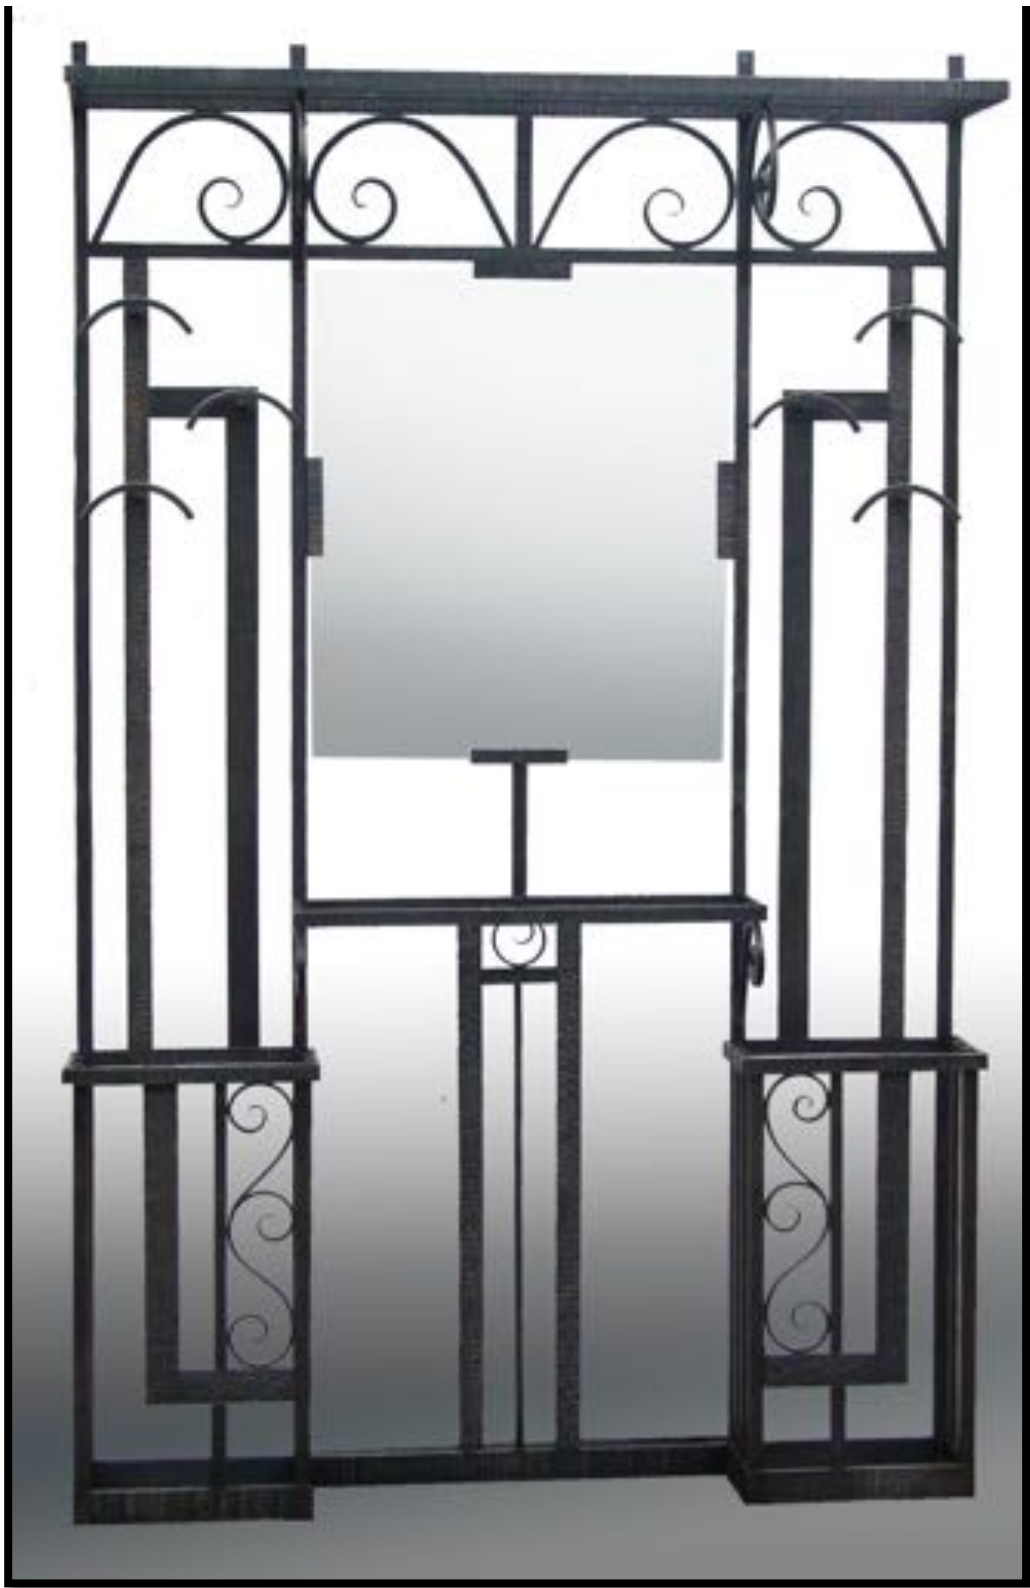
Here is a photo of the completed coat rack. Our client was quite pleased with the results.
