## **Restoring the Southampton Arts Center Gates**

Last December, we were approached by a private building company with the request to restore and refinish a pair of antique entry gates. These beautiful turn of the century style gates have stood on the grounds of the now landmarked Southampton Arts Center (formerly Samuel L. Parrish Art Museum) building since its original construction in 1897. After viewing the gates, we knew that it would take our unique expertise to restore them and stay true to their original historical integrity.

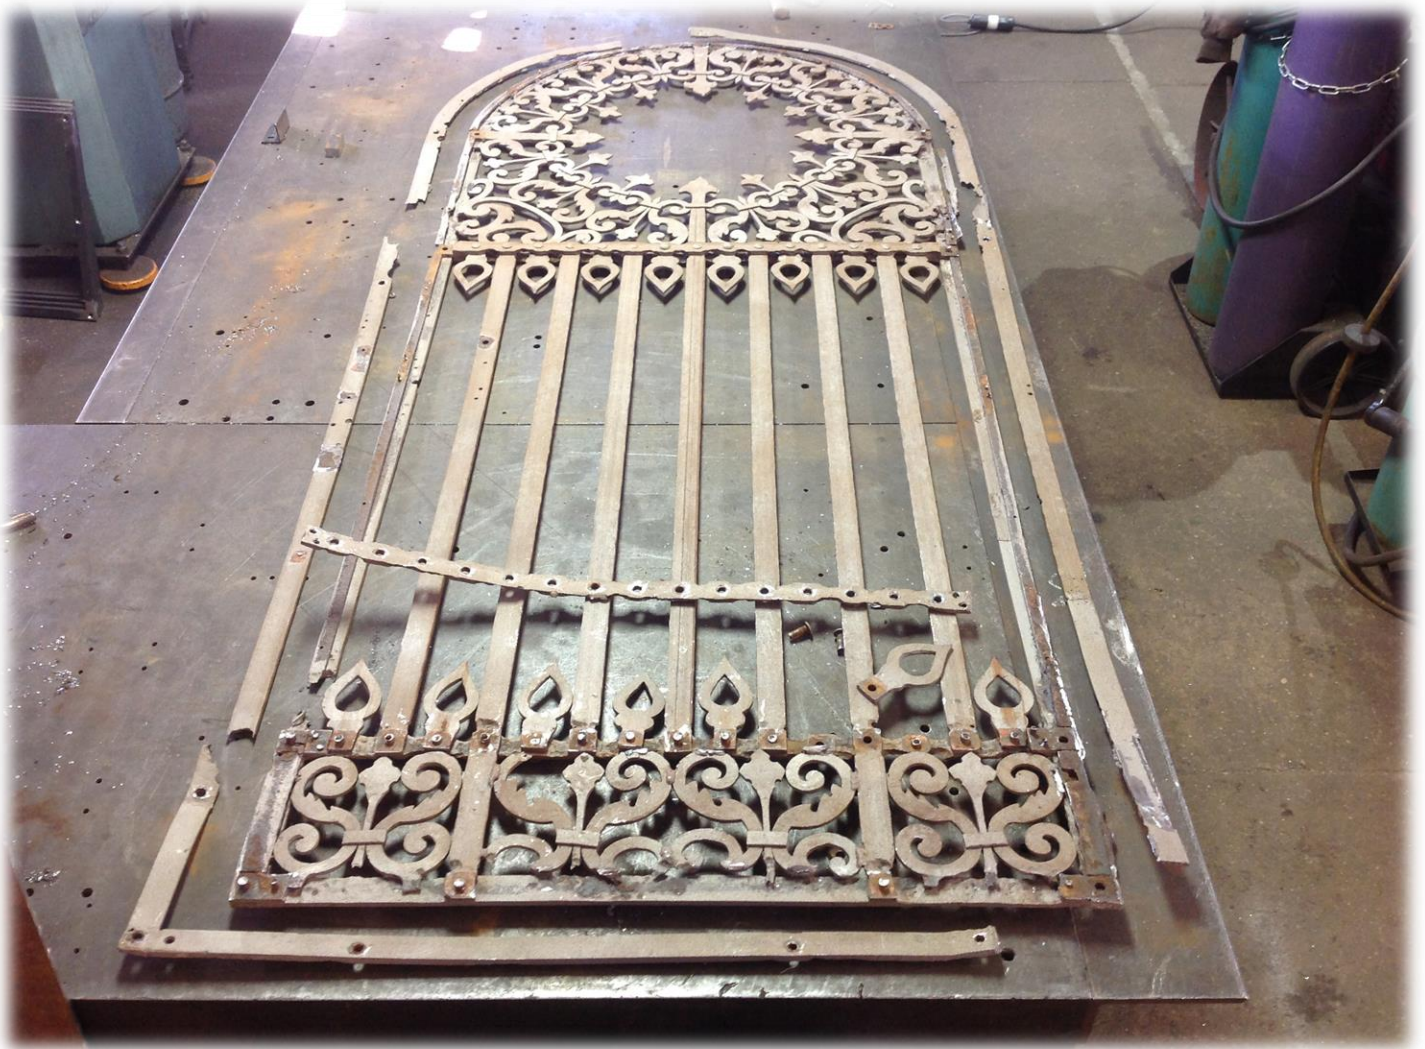
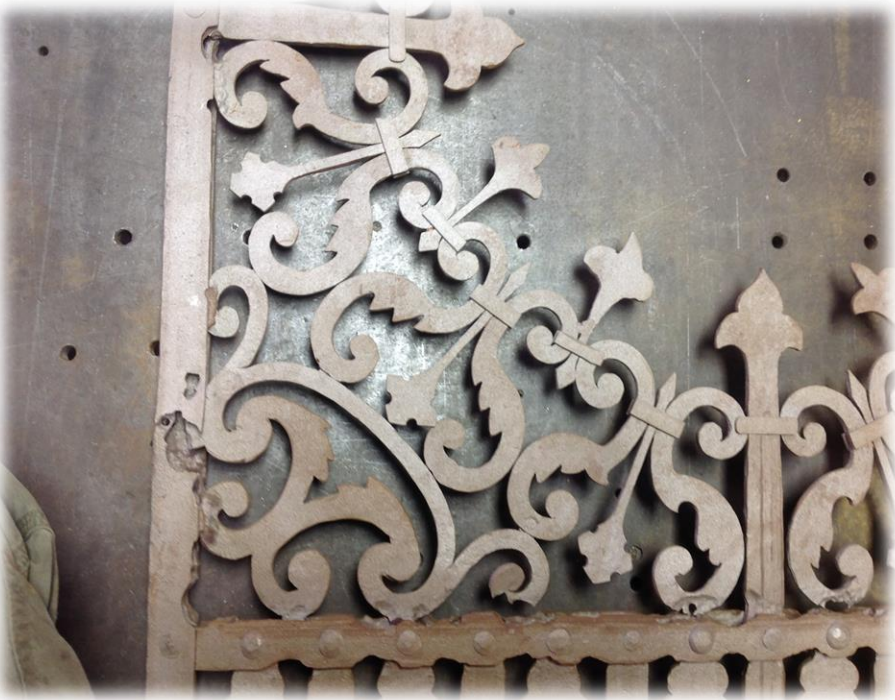
After closely assessing the gates, we found that the frames, crossbars, and some of the infill were badly rusted and required either extensive repair or in some cases, complete replacement in certain areas. Here, you can see an overview of the rust, wear and damage.

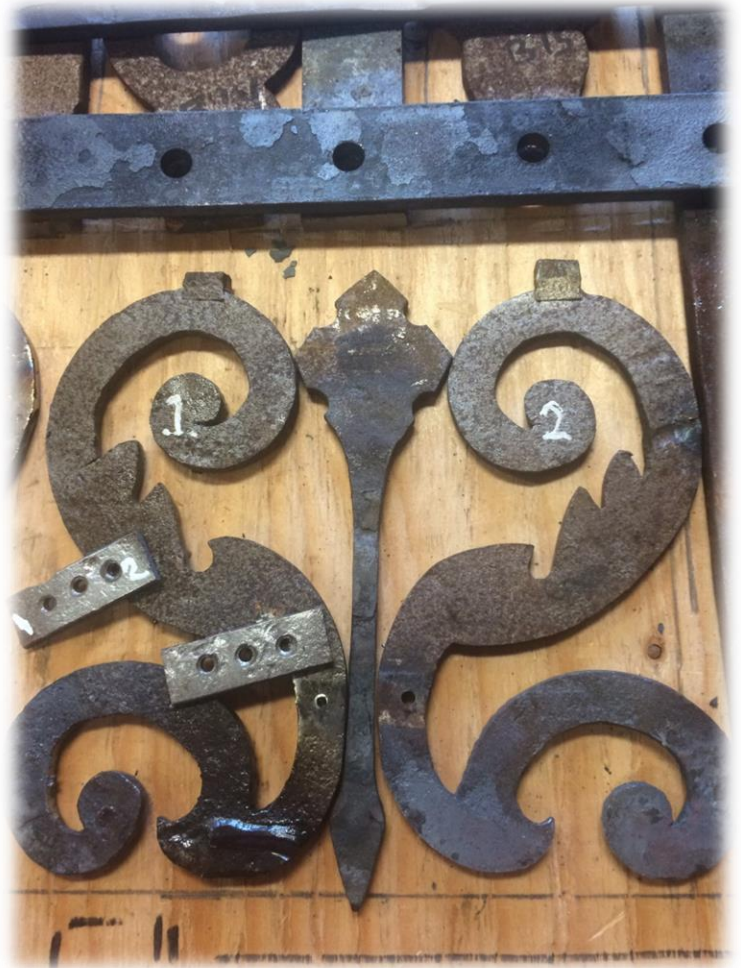
Once assessed, the gates were then completely disassembled. During this process, we found that all of the metal components within the gates were held together with mechanical connections. The majority of these connections were riveted together so each rivet had to be drilled out individually.

We then carefully cataloged all dismantled components noting their original locations for reassembly. Plywood templates of the original gates were also created so that our craftspeople could lay out each piece as they were being repaired.

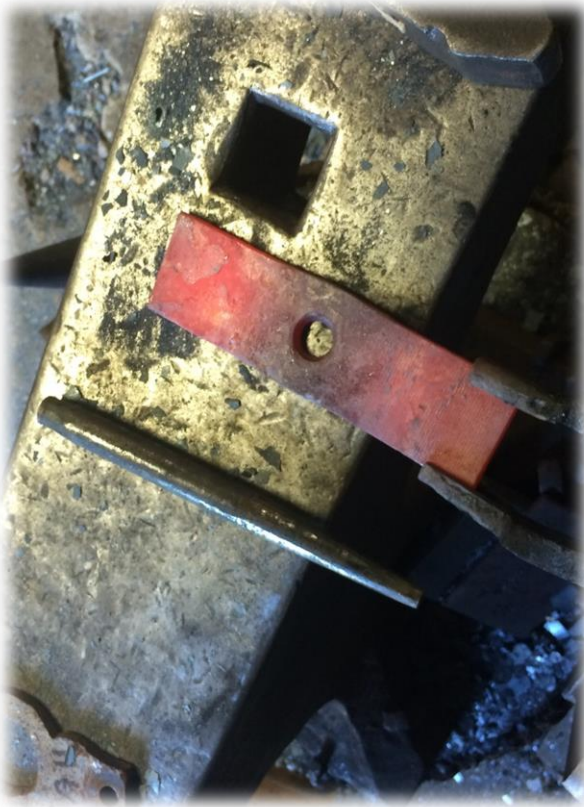
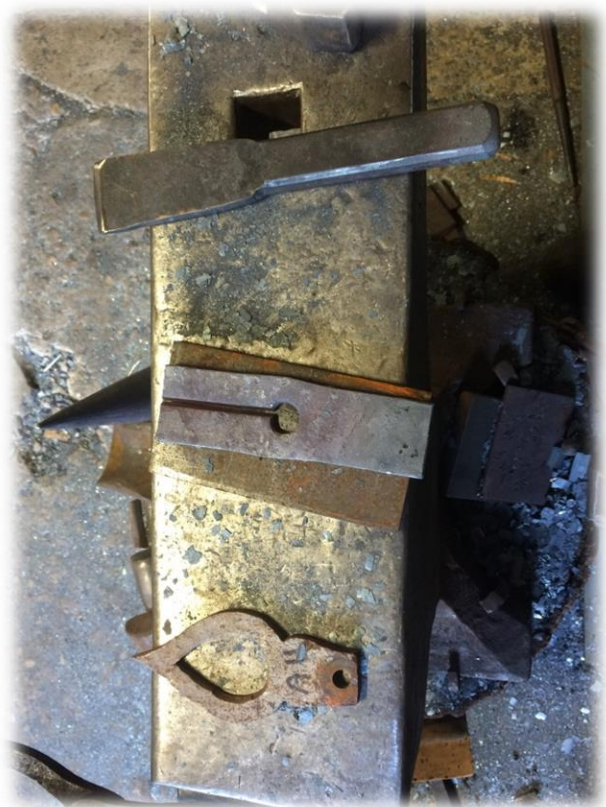
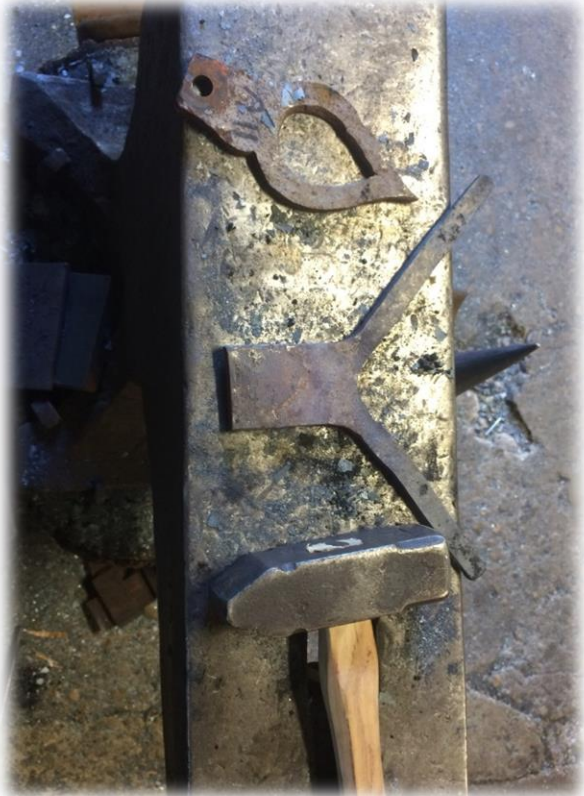
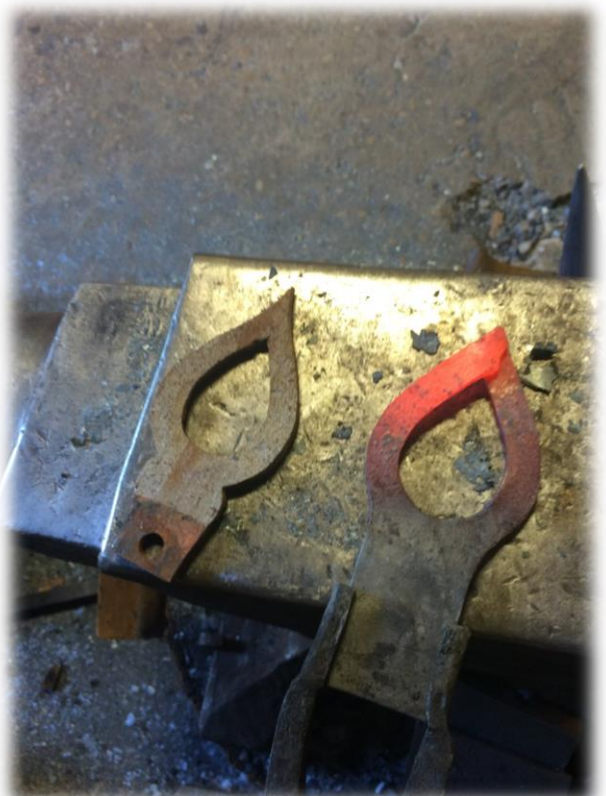
Our next step was to replace some of the forged elements that were either missing or too damaged to be restored. Above are a series of photos that illustrate the various traditional blacksmithing techniques and tools that were necessary to make some of the pieces.

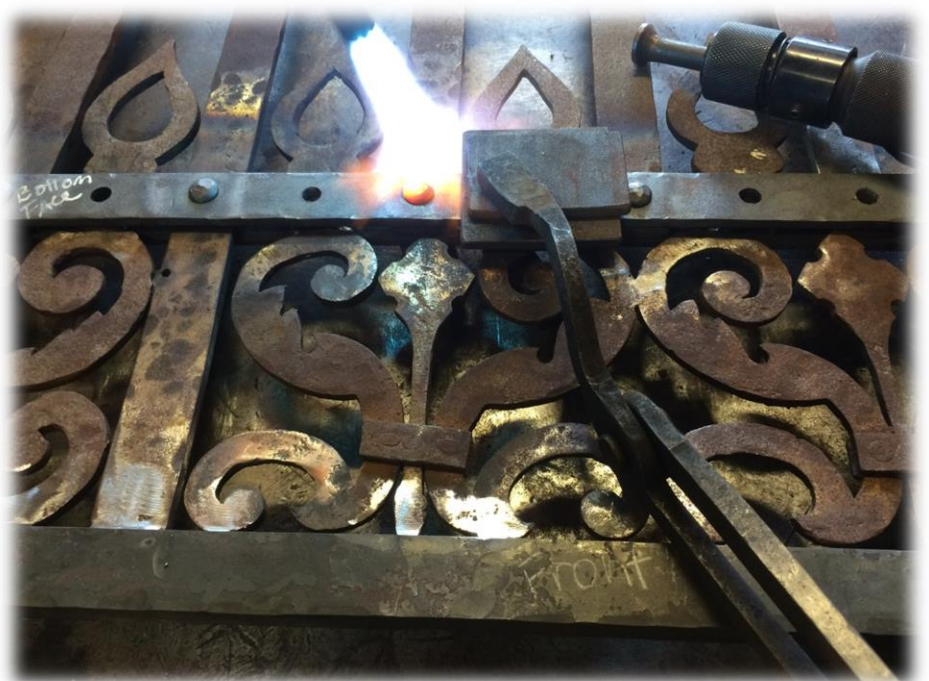
Once every component had been replaced or repaired, they were reassembled on our fabrication table and prepared to be riveted back together. Much like building a puzzle, each piece had to be fitted properly in order to ensure the accurate assembly of the gate.

Prior to riveting, the gate was assembled using bolts to ensure correct alignment and fit. One by one, the bolts were removed and replaced with a rivet. These rivets were then heated with a torch and “headed” using a pneumatic gun.

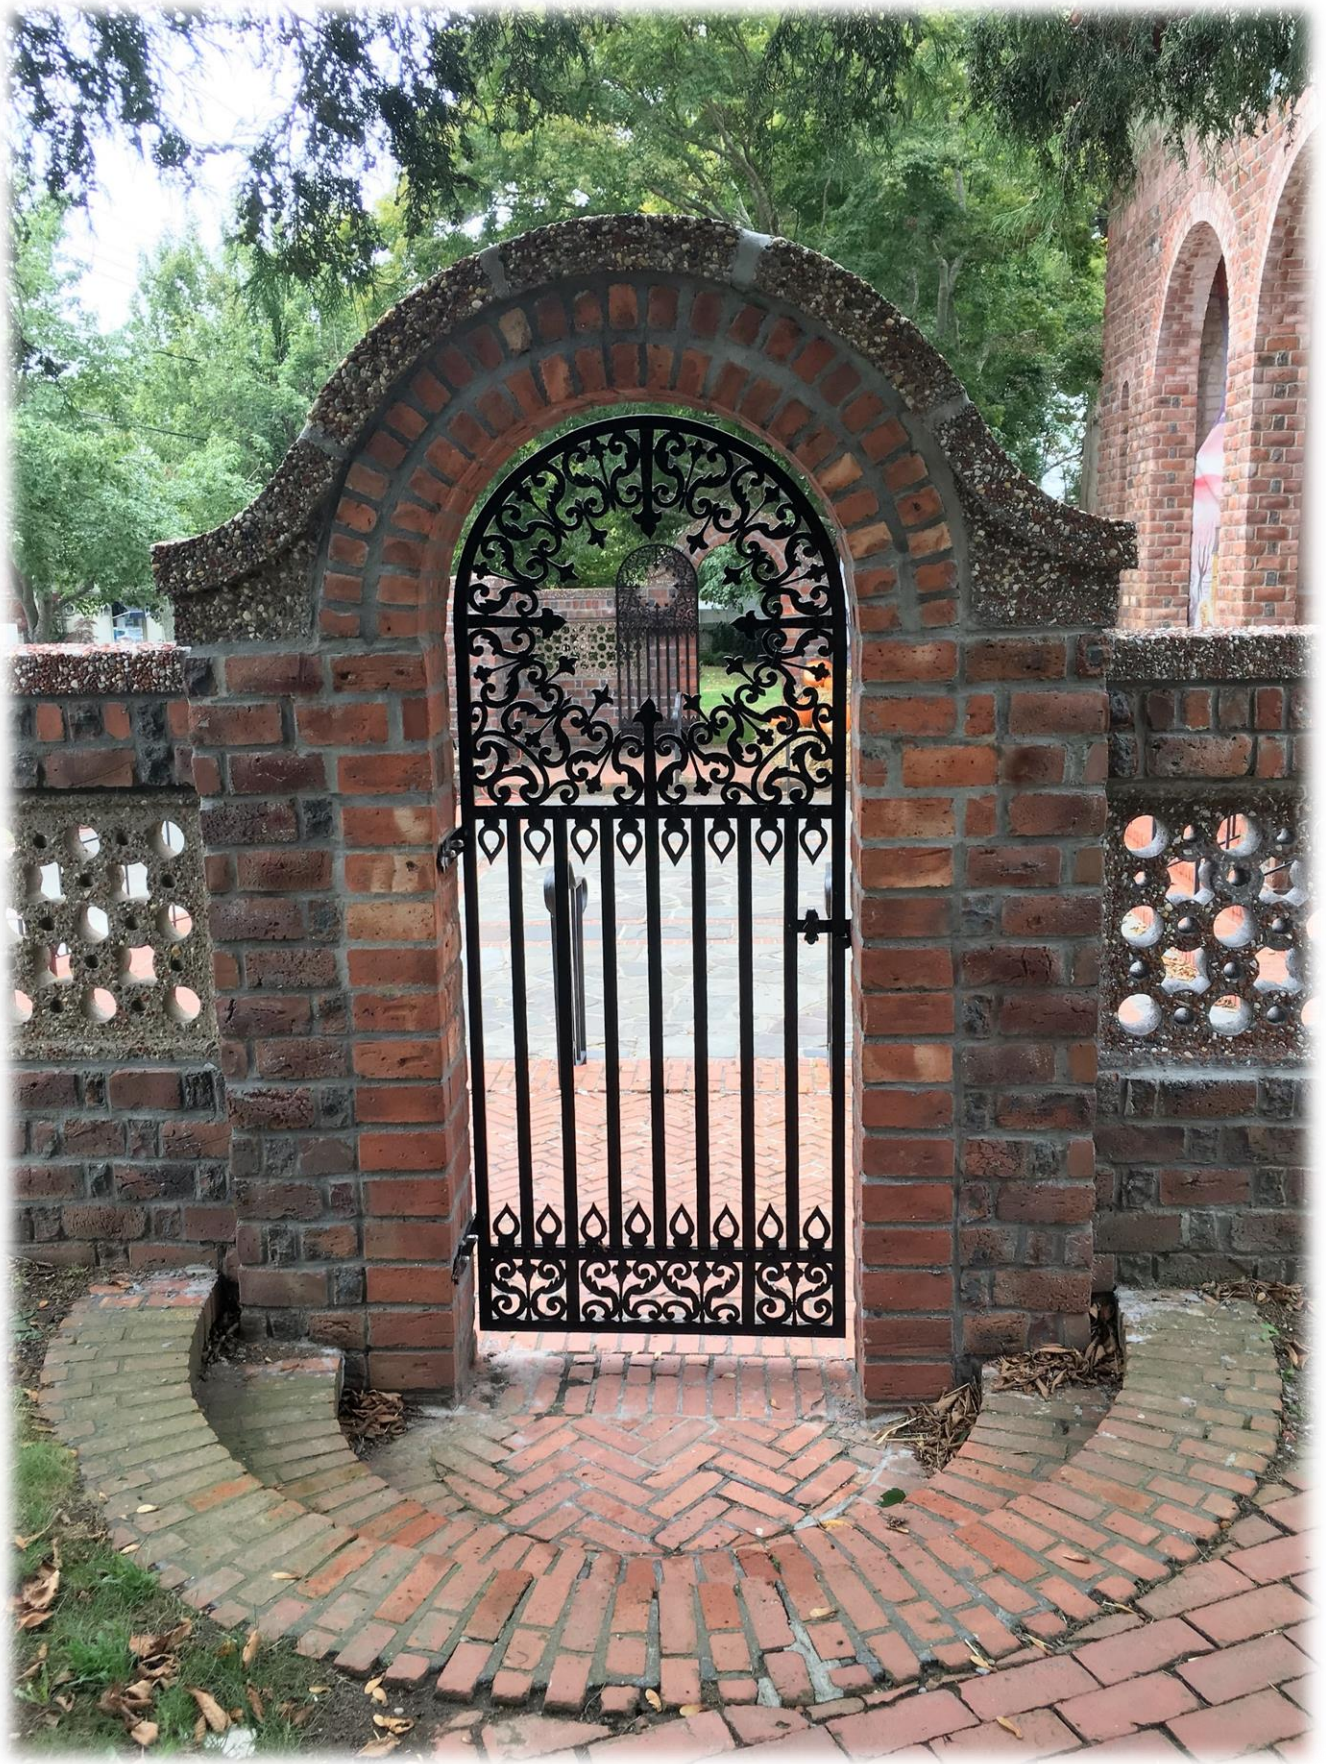
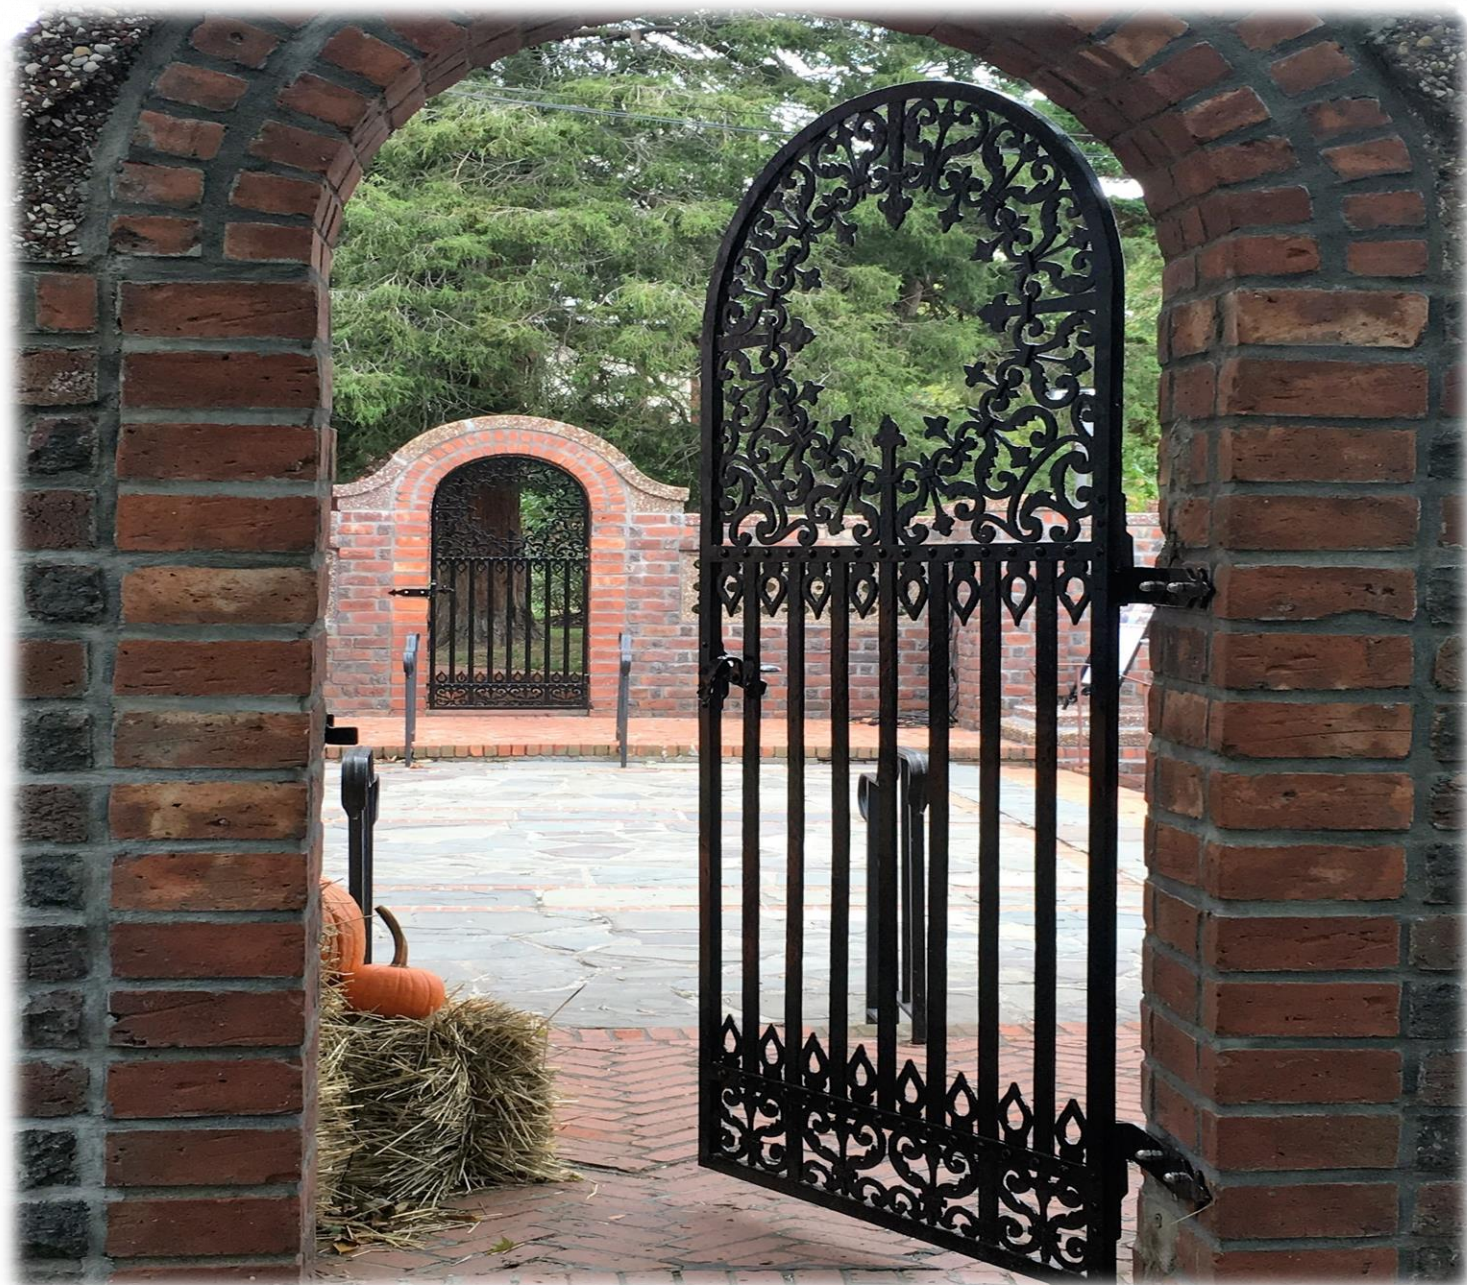
Here are the restored gates re-installed in their original locations complete with a new latches, custom hinges, metalized and painted finish. They are now ready to withstand years of service.
