Woodland Cemetery Gate

A Case Study

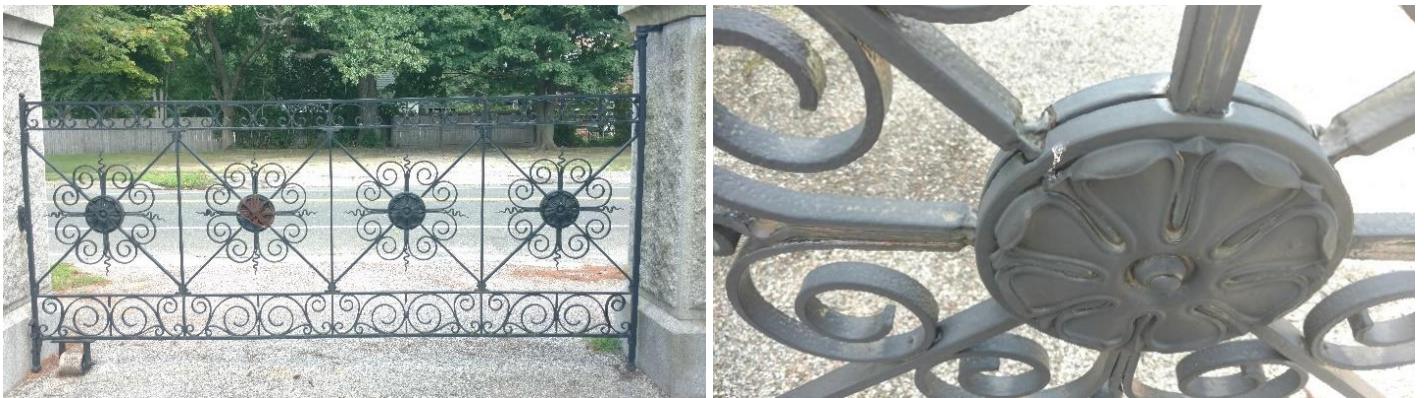
After over a century of service this well-crafted piece of ironwork was in dire need of restoration. Constructed before the invention of electric welding, every joint was either riveted or screwed together. Over time rust has crept into these joints and pushed them apart or completely disintegrated them. After recognizing the quality of work that Spirit Ironworks was able to accomplish with the sculpture, the Village knew the Cemetery Gate would be in good hands.

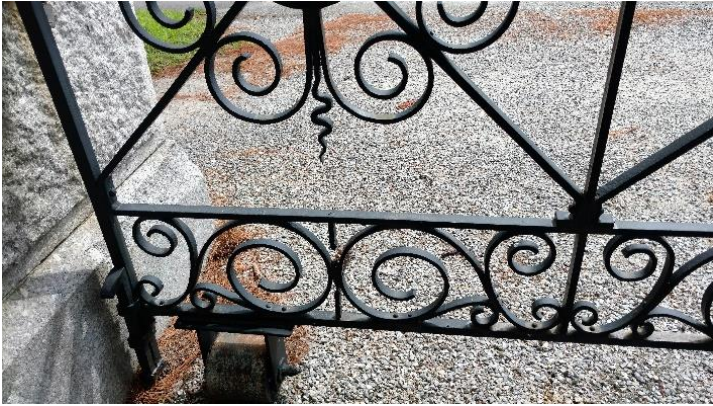
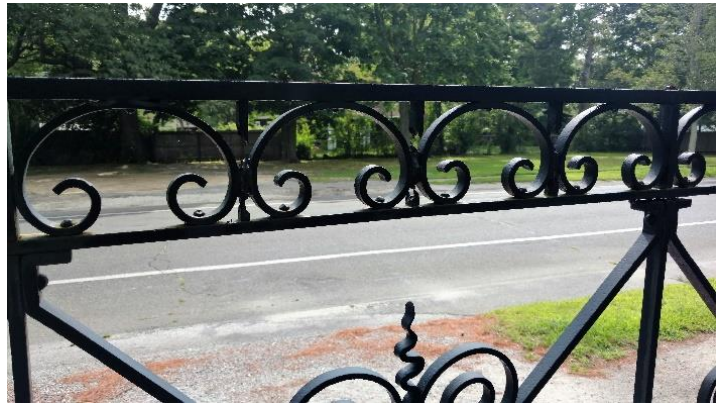
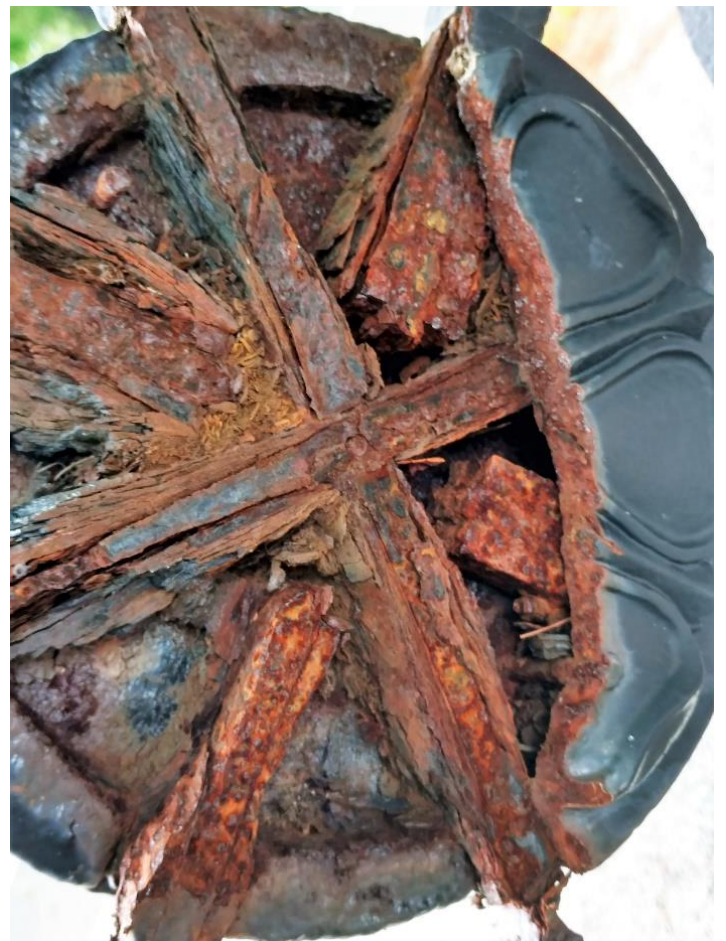
Here we can see the amount of wear the Gate has sustained over the years, including the Cast Iron rosettes that were severely damaged. Understanding how intensive this restoration was going to be, Spirit Ironworks began the process of carefully removing the gate. Once taken down, the gate was sandblasted to get rid of the paint and reveal the true extent of the damage. After this was completed the underlying damage to the gate was worse than expected.

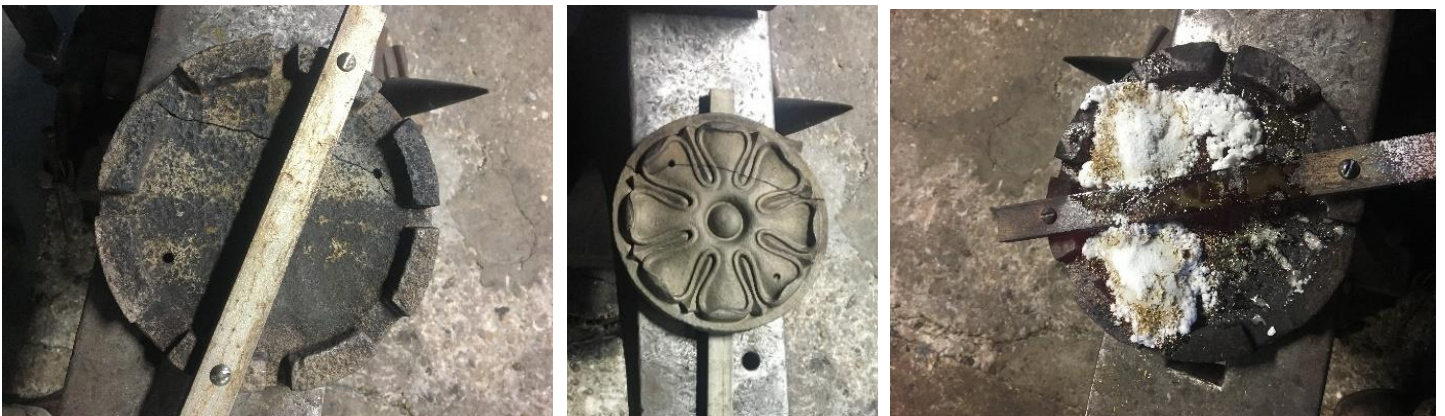
One of the things that many people may not understand about ironwork from this period, is the great expense and care that went into its construction. In general, older ironwork has a greater variety of decorative elements and design features. For example, the cast iron medallions are actually structural elements of the gate. They secure the scrollwork and strengthen the centerline of the gate. Cast iron is extremely difficult to repair and needs to be approached very carefully as it can become brittle and crack if not heated and cooled properly.

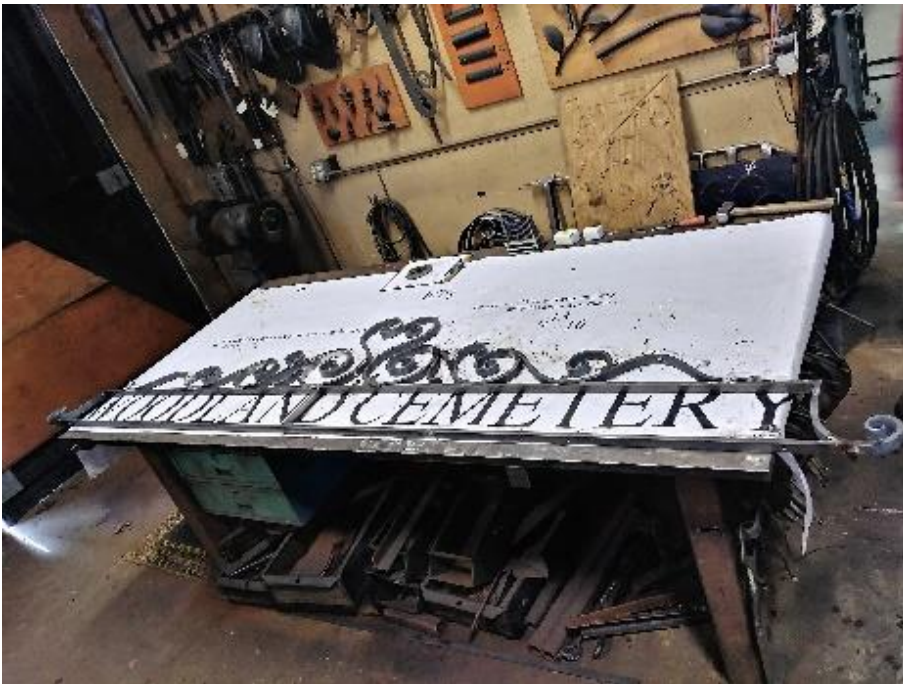
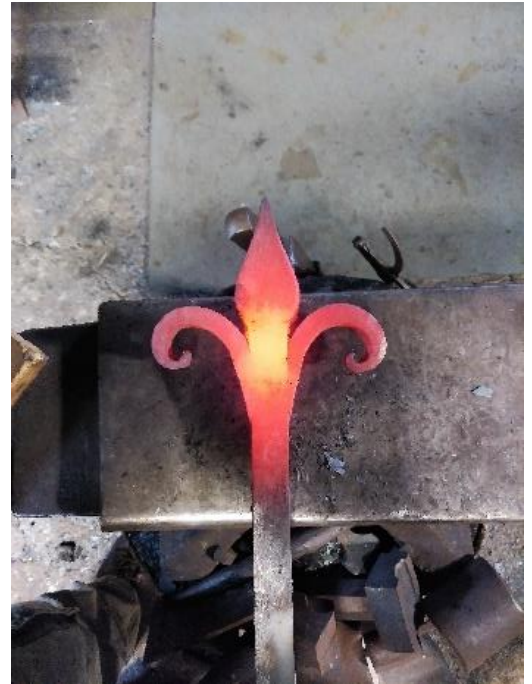
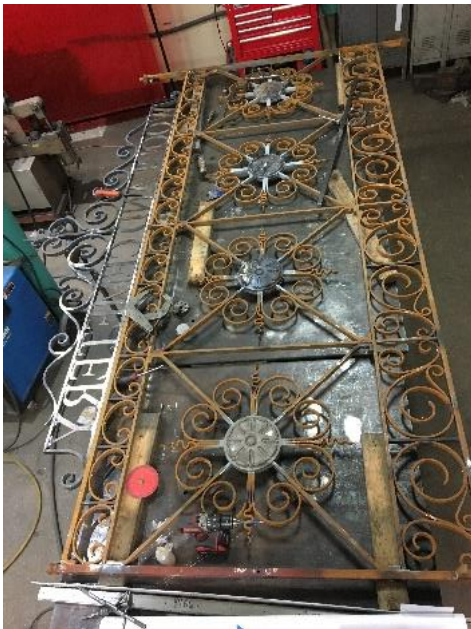
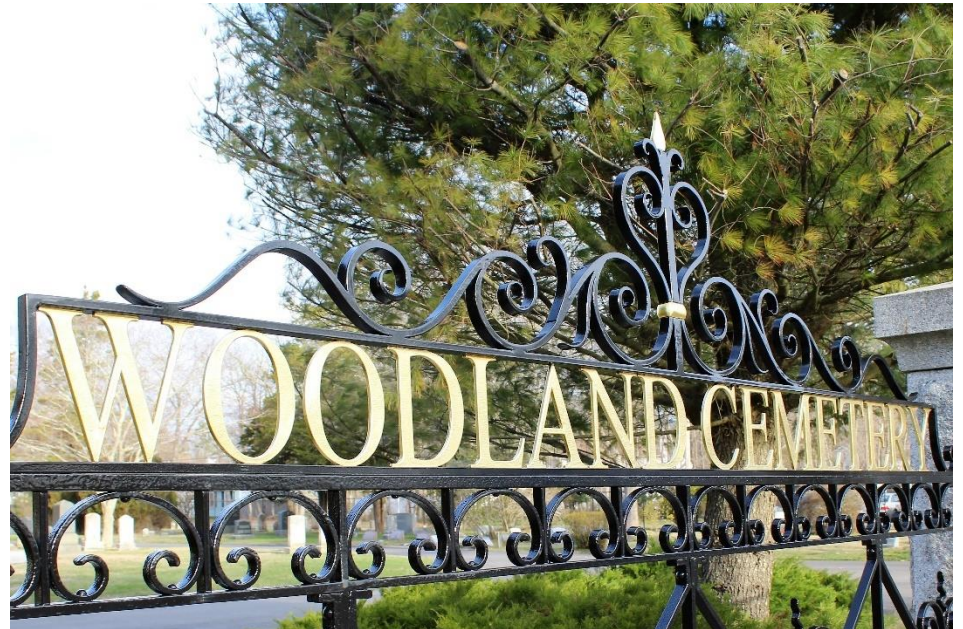
Inspired by the Lakeview Cemetery restoration, we were asked to design and forge a decorative frieze to be attached atop the gate. Being the main entrance to the cemetery, the committee felt that the gate should be more visually striking. The new frieze has the historical cemetery's name in genuine gold leaf to adorn the top of the gate.

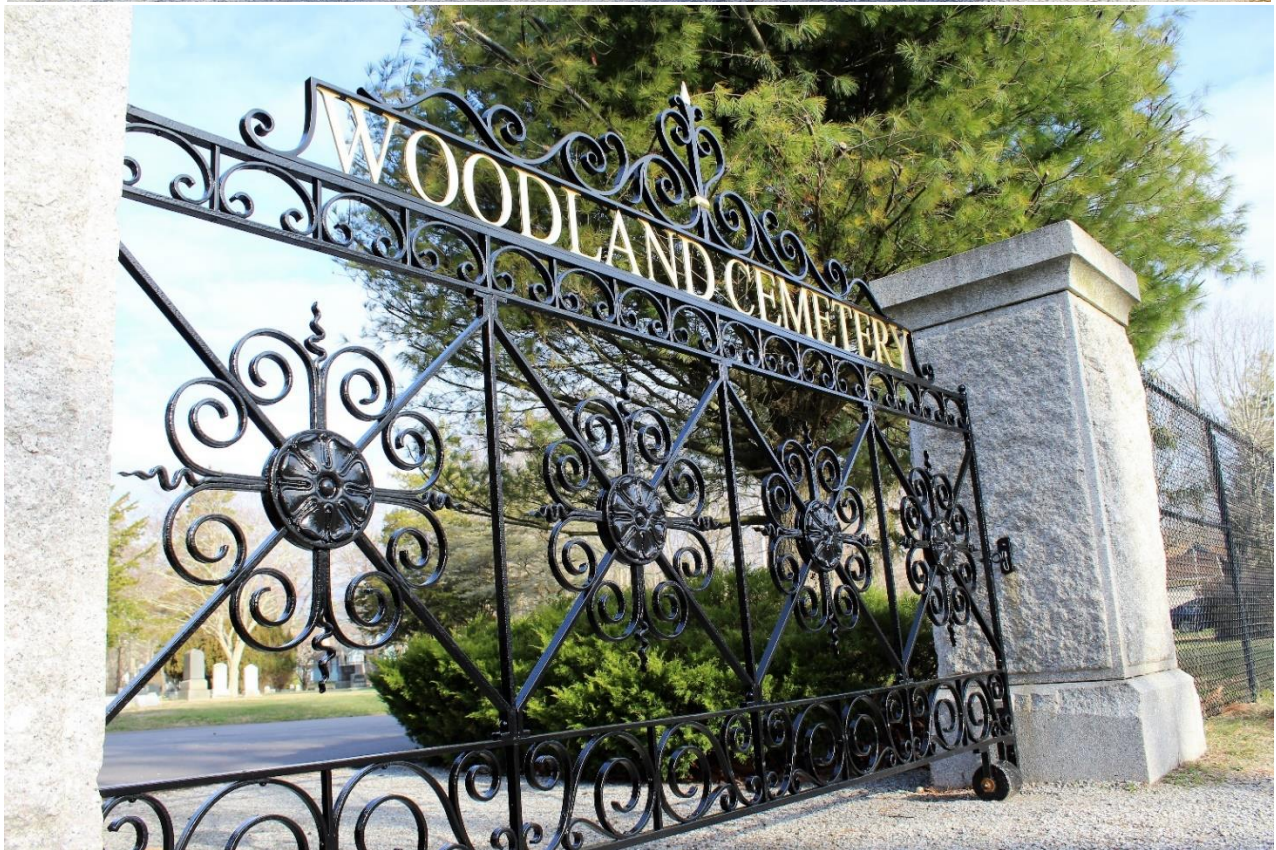
After many hours of extensive restoration by Spirit Ironworks, the Beautiful Woodland Cemetery Gate is ready again for decades of service.
