RESTORING HISTORICAL IRONWORK

A Case Study

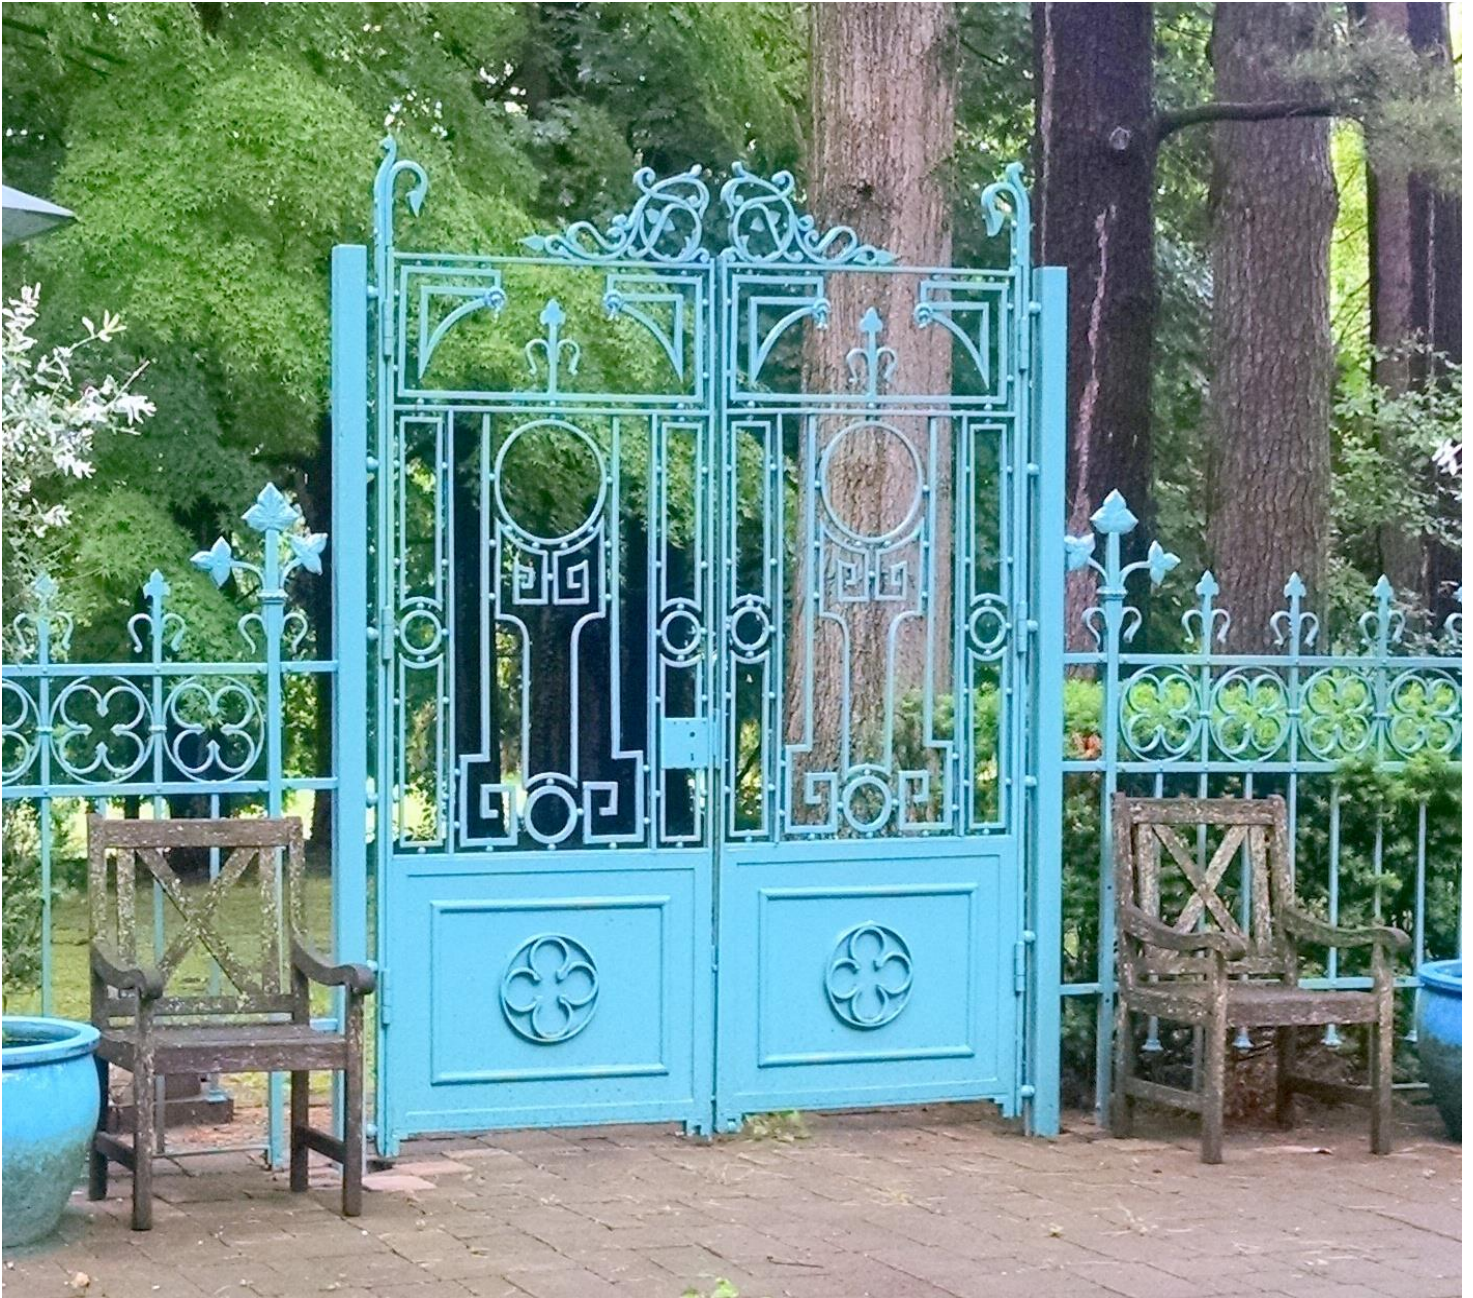
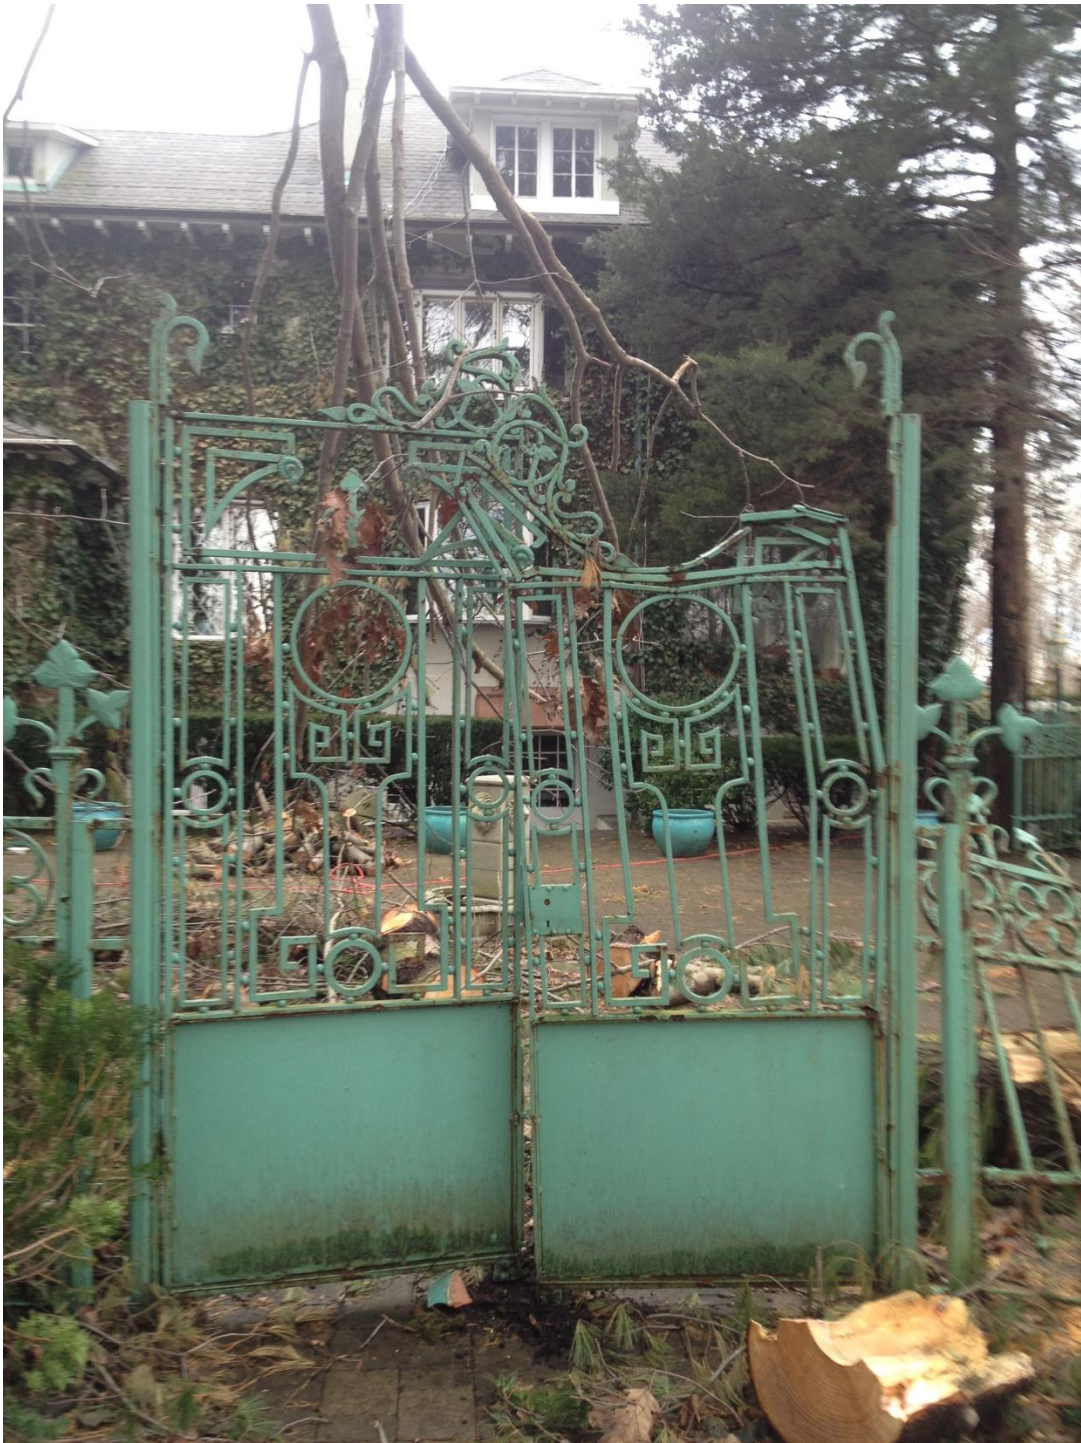
Spirit Ironworks was approached by a local client who wanted to have her antique fencing possibly from the late 1800's restored. The ironwork, located in Historic Old Field on the North Shore of Long Island, was badly damaged when a large tree and other debris fell on it during hurricane Sandy in 2012.

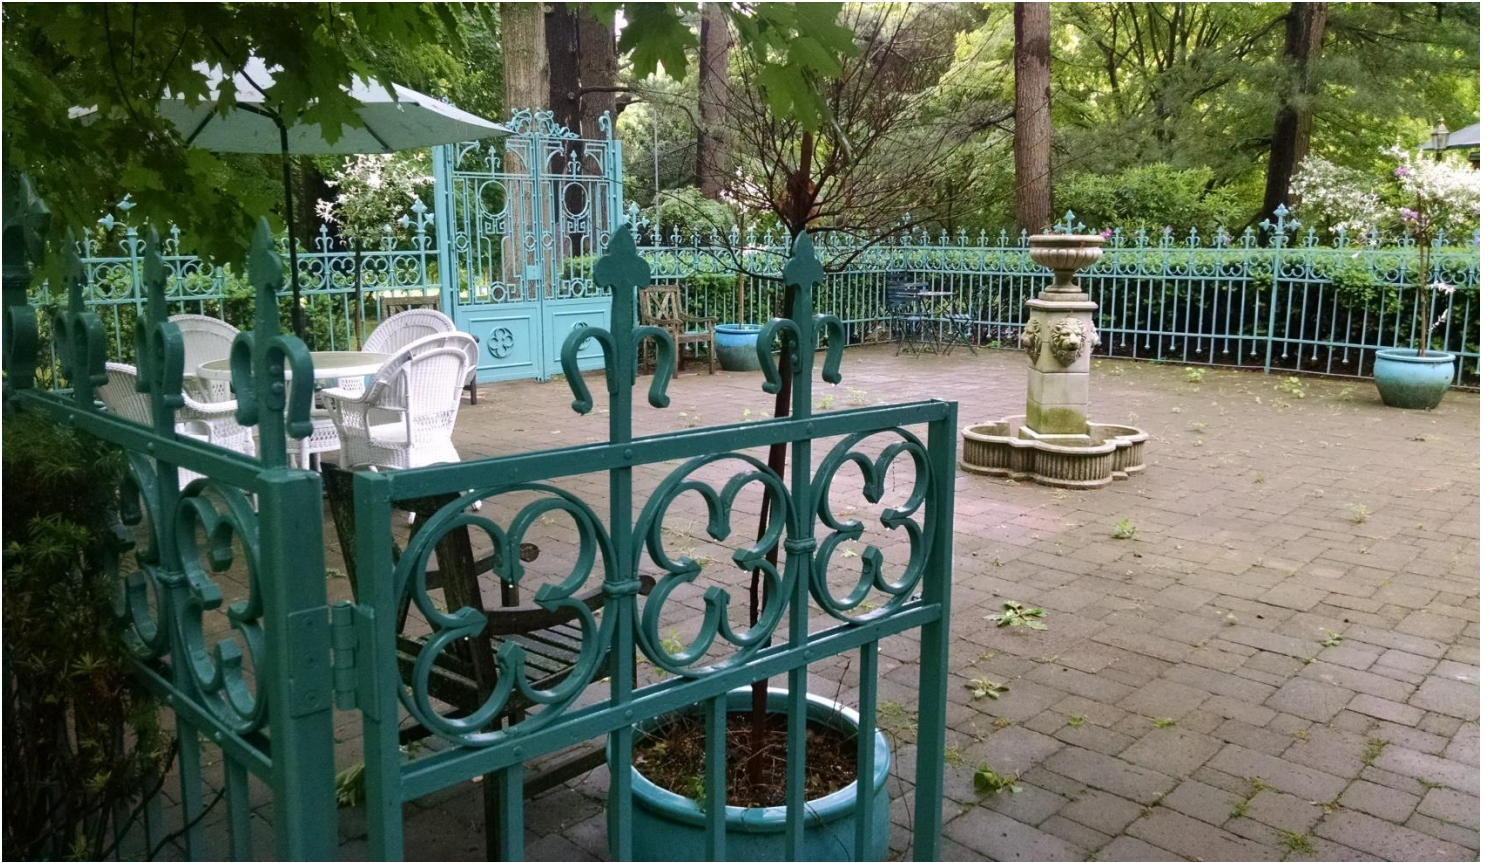
Here we can see the restored ironwork in its splendor ready for another 100 years of service.

The final step before installation was to have the ironwork painted in a custom blended color in order to match the ironwork's existing finish.
