## The Restoration of the Henry Street Settlement Exterior Ironwork

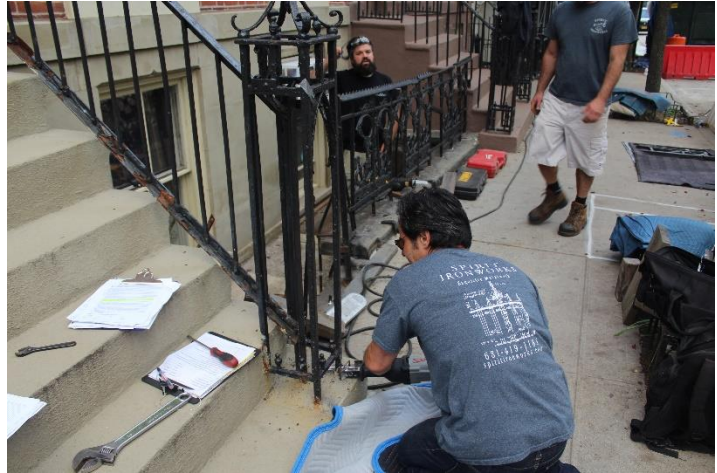
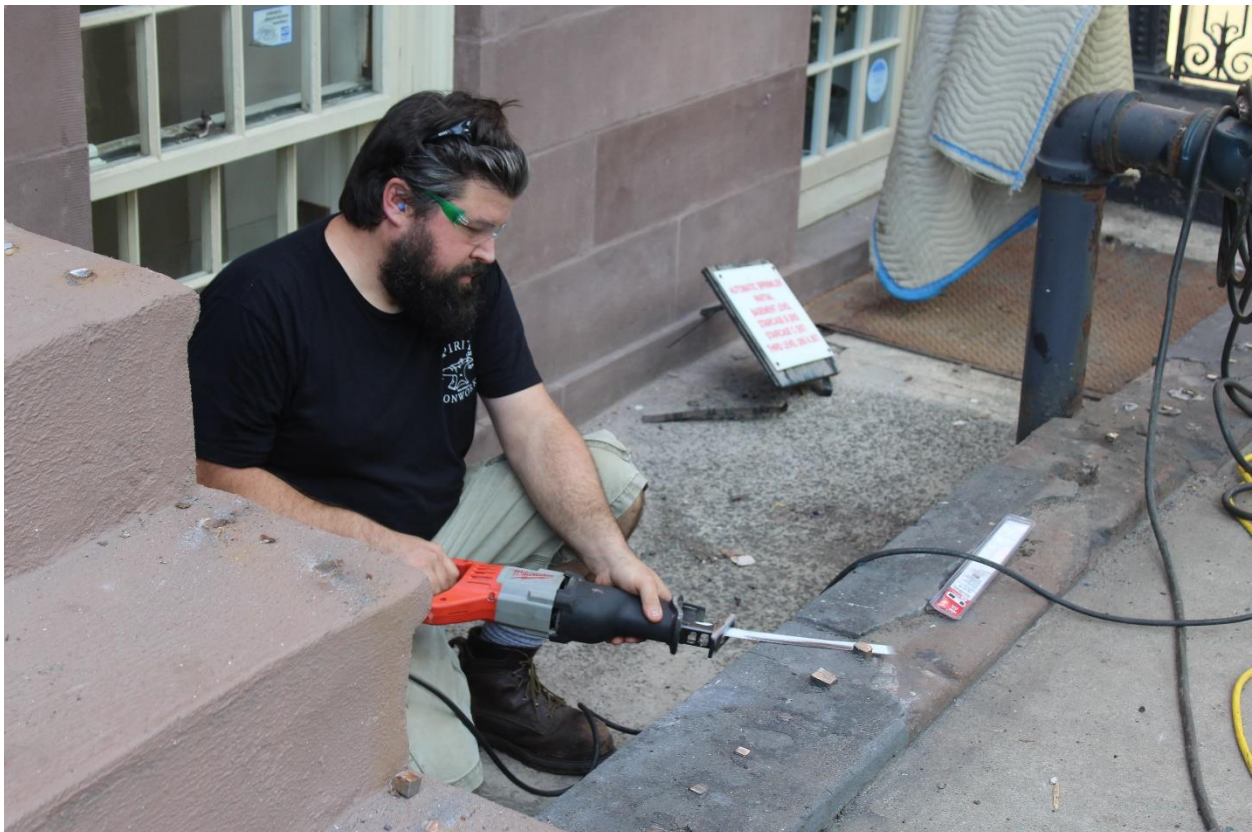
Once the site was surveyed and the initial assessment was completed, our next step was to travel back to site and carefully measure and remove the damaged ironwork. Each section was then transported to our studio where they were photographed, cataloged, and prepared for paint removal.

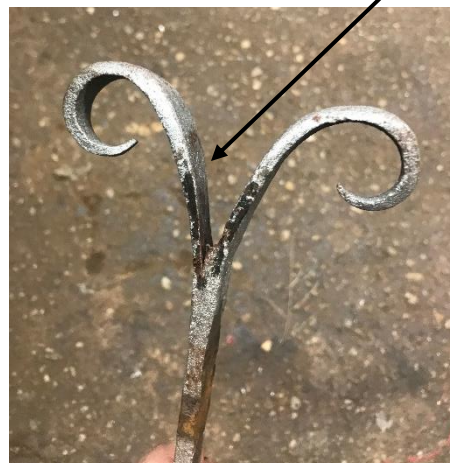
The damages to the original loafer railings sections were extensive. We removed 5 sections in need of restoration. The top bars were badly bent out of shape and some of the spikes were either damaged or missing. In addition to the 5 damaged sections, we noted a railing section whose loafer rail was missing entirely. This railing section was particularly interesting as we noticed that the bottom fleur de lis scrollwork was quite worn-down displaying that they had bared both weight and friction for some time. It became evident that the spikes were purposely removed so that the railing could be sat upon while the scrolls were used as footrests.

The restoration of the loafer rails found outside of 267 Henry Street was an involved process. The initial step was to straighten the badly bent top bars by heating them at our forge and straightening them with a hammer. The missing top bar was remade using reclaimed genuine wrought iron that was forged and hammered to match the style and dimensions of the existing pieces. The missing spikes were also remade using genuine wrought iron. The images below illustrate this process. They show our blacksmith cutting and shaping each spike to match the original forms. Once made, each spike was passed through the openings of the top bars and forge welded into place. This method of recreation was very much in line with the original method of construction during the 1830s.
